## CONDITION SURVEY REPORT FOR 7M GRP MOTOR CRUISER

Date of Survey: April 2026

Location: İzmir Region (Haul-out yard)

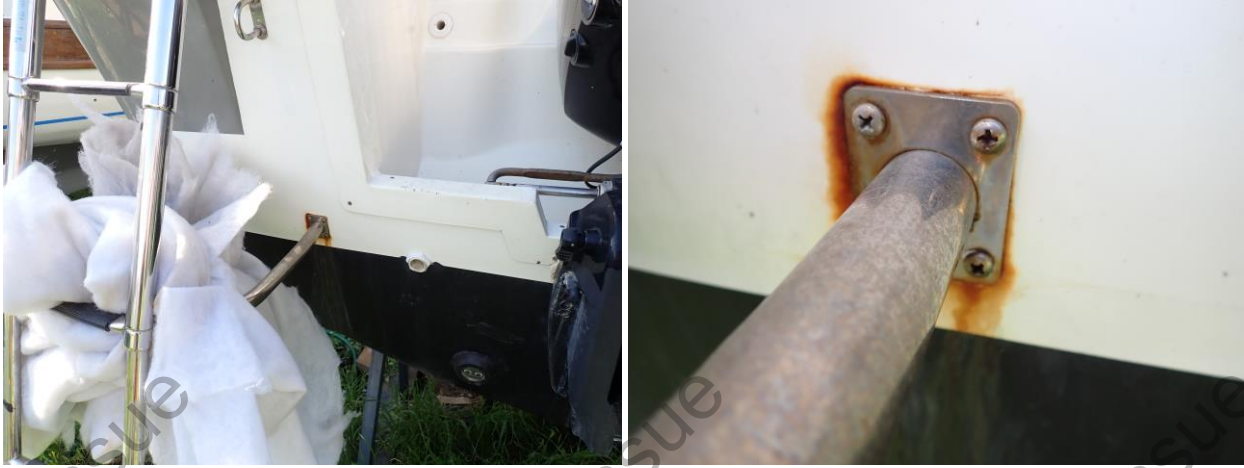
Small swim platform next to the outboard engine, also used as the ladder storage. The stainless steel tubular supports for the swim ladder/step are secured directly to the vessel's transom. The tubular stainless steel itself appears structurally intact, though it shows minor surface staining. There is distinct rust weeping (iron oxide staining) bleeding down the transom fiberglass from behind the circular mounting flanges. This strongly indicates that the hidden fasteners securing the mounts to the hull are actively corroding. This is typically caused by the use of non-marine grade fasteners (e.g., lower-grade stainless or galvanized steel) or crevice corrosion due to failed bedding compound allowing moisture to become trapped.

**Fastener Renewal:** Remove the mounting hardware and extract the corroding fasteners.

**Cosmetic Repair:** Clean the rust staining from the surrounding transom gelcoat/fiberglass using a specialized rust remover (such as an oxalic acid-based cleaner).

**Re-bedding:** Secure the fittings using new, properly sized marine-grade (316) stainless steel fasteners. Critically, the fittings must be thoroughly re-bedded with a high-quality marine sealant to prevent future moisture intrusion into the transom structure.

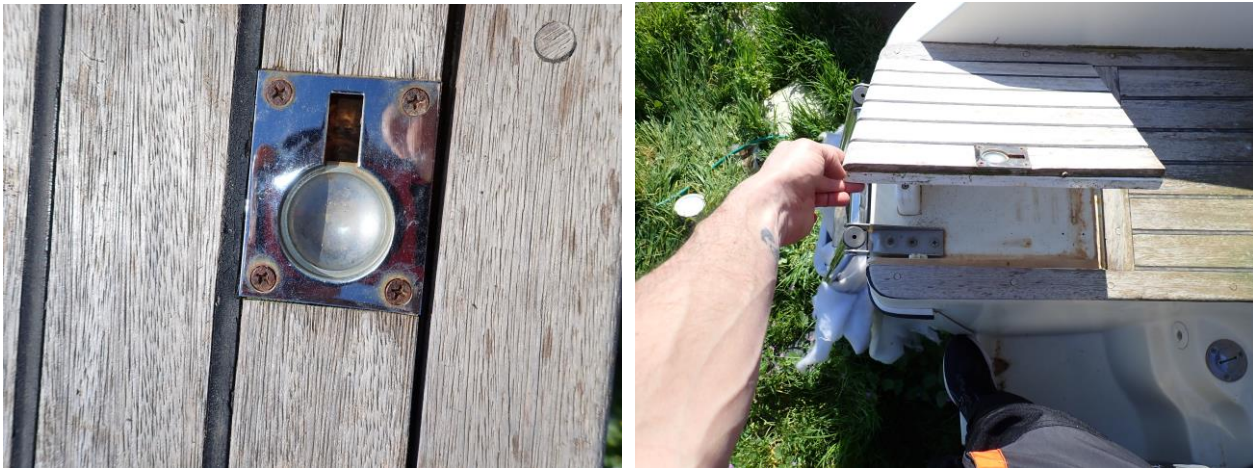
The stainless-steel hinges for the fold-down boarding ladder appear to be in good condition, though minor surface staining is visible. The storage flush ring catch is broken, and four screws securing it are heavily rusted, indicating they are likely not marine-grade 316 stainless steel (they may be mild steel, galvanized, or a low-grade stainless). The white fiberglass gutter/recess beneath the hatch shows distinct brown rust staining. This is a direct result of water washing over the corroded screws on the catch and depositing iron oxide into the drain area.

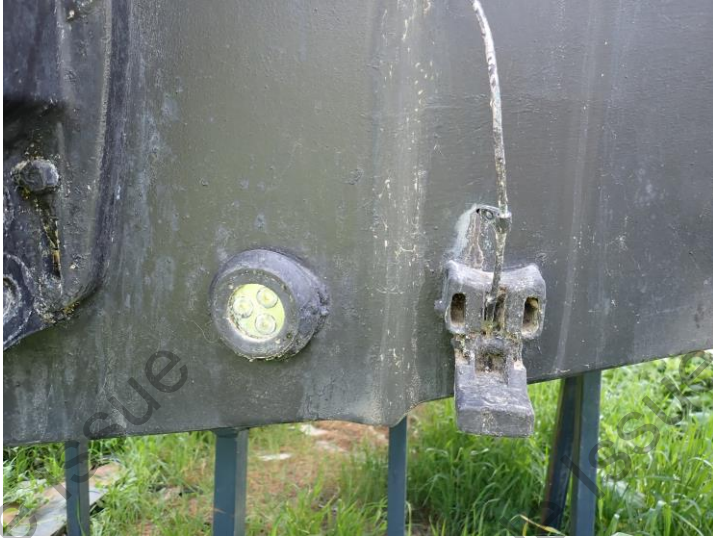
Painted. Should not have been painted. The transducer face itself remains uncoated; however, full functional verification should be carried out when the vessel is afloat.

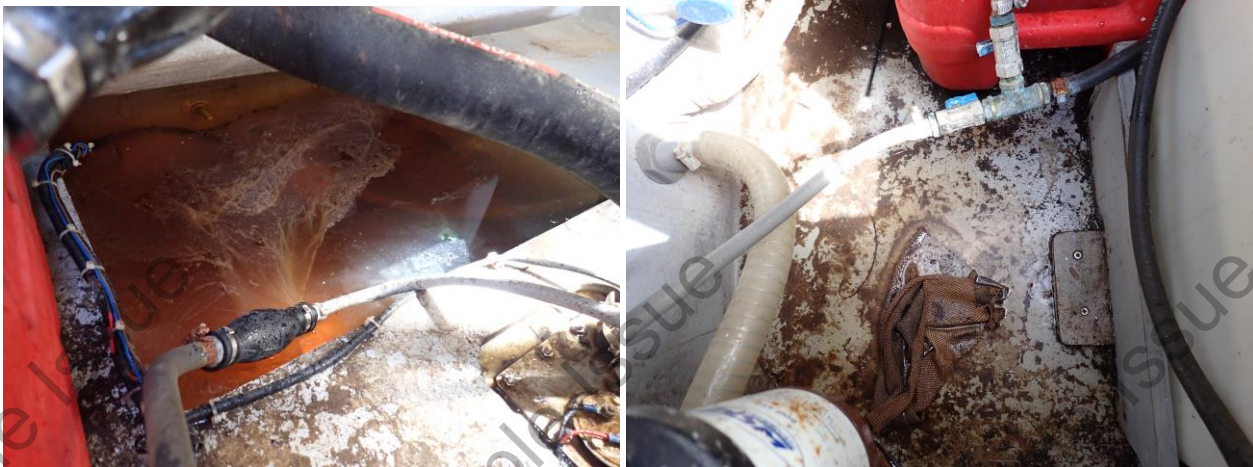
No sign of moisture detected on the exterior of the hull except on the aft close to the transom. When inspected from the inside, water was found in the interior of the transom, inside the aft bilge. There is a bilge pump inside but because the batteries are disconnected the pump is not operated.

The water observed in many areas such as the bilges, the storages and the moist cockpit sitting cushions are because of the boat's heavily deteriorated top cover, which allows the rainwater in.

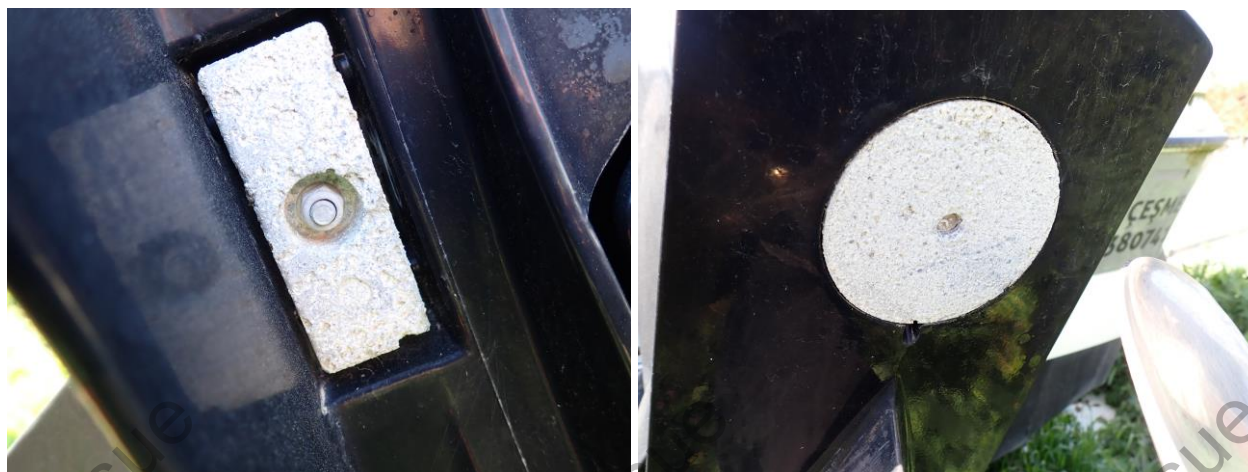
2 outboard motor anodes are depleted and need to be replaced

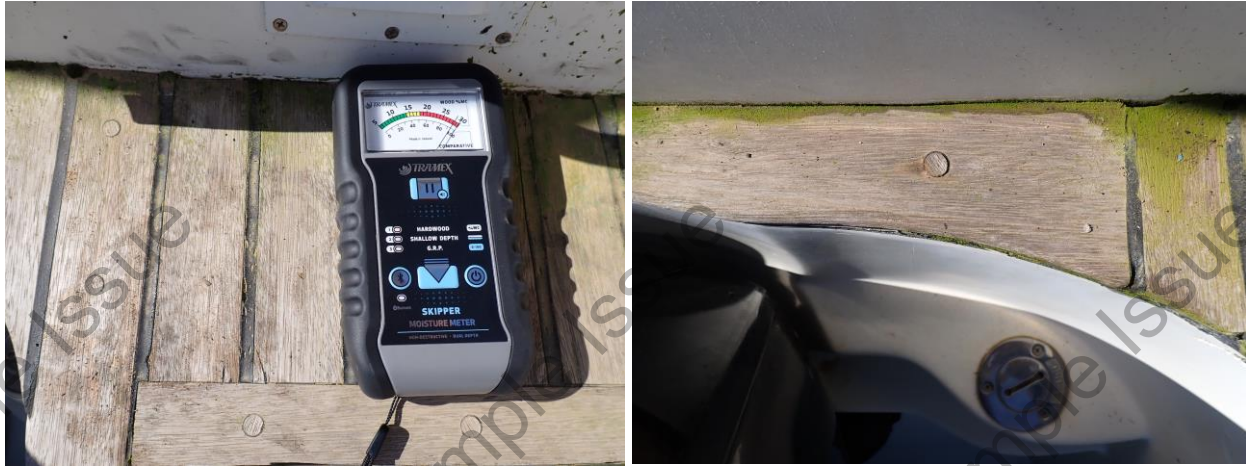
along the forward edge/lip of the wooden hatch. This indicates moisture retention in that area when the hatch is closed. On the stern of the boat, the “swim platform” area, the teak is weathered but appears structurally intact. However, the black caulking appears to be failing slightly, showing minor separation or degradation from the edge of the plank. There is green algae or moss visible along the inner edge where the teak meets the vertical white fiberglass surface. This indicates that water tends to pool or linger in this corner rather than draining away completely.

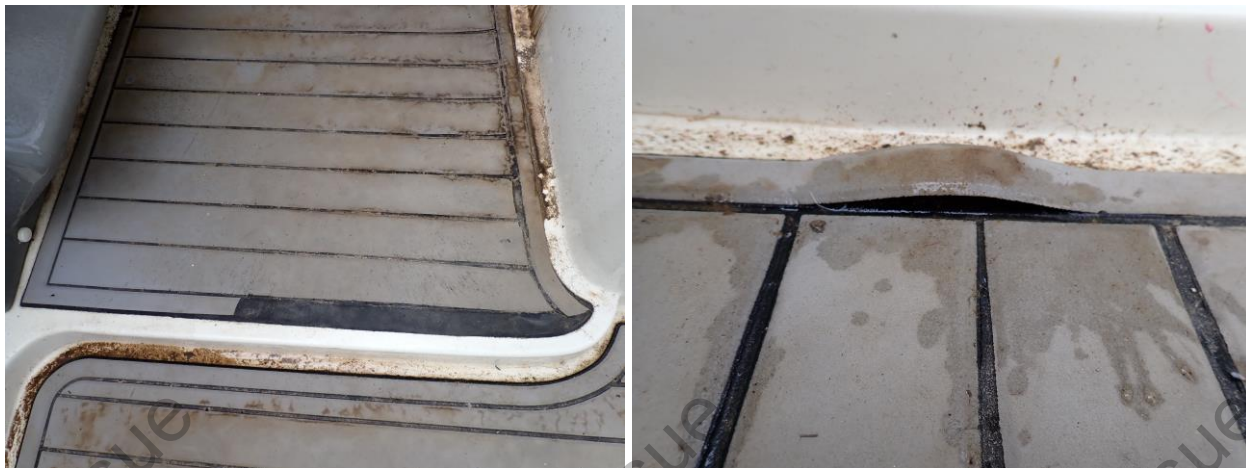
The synthetic soft-deck flooring in the cockpit sole area exhibited localized edge lifting and partial adhesive failure, particularly along the perimeter margin adjacent to the coaming return. Surface contamination, trapped moisture, and minor biological staining were also visible within the margin channels. The affected flooring section should be lifted locally, the substrate thoroughly cleaned and dried, and the material re-bonded or renewed as required using a marine-grade EVA deck adhesive system.

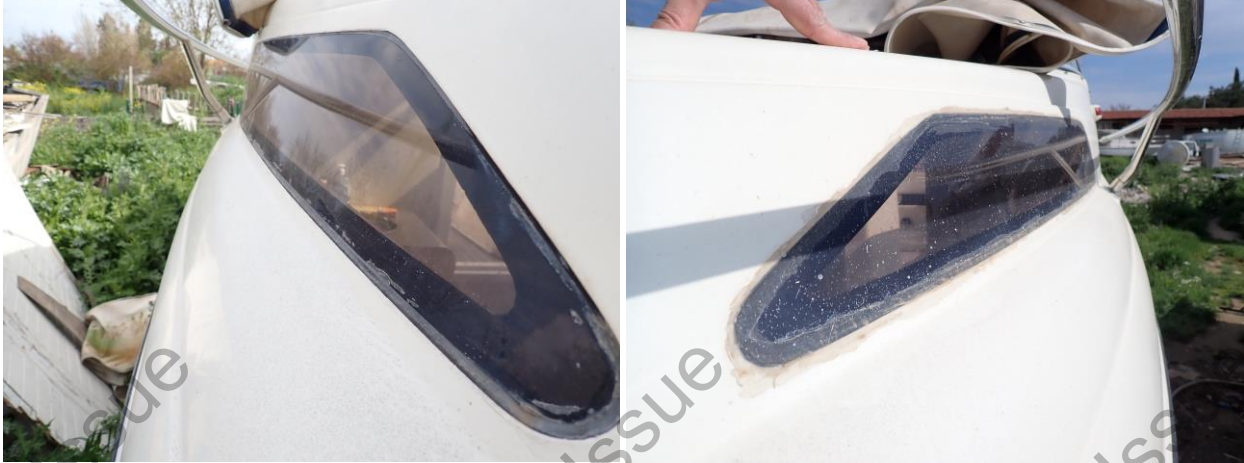
In good condition but poor craftsmanship observed. Should be inspected regularly. Starboard cabin window looks like it was redone with silicone, possibly due to a leak.

- Re-bed starboard cabin window previously repaired with silicone.
- Clean and preserve teak surfaces and failing caulking margins.
- Inspect transducer performance afloat due to antifouling paint contamination.
- Renew mooring cover to prevent continued rainwater ingress.

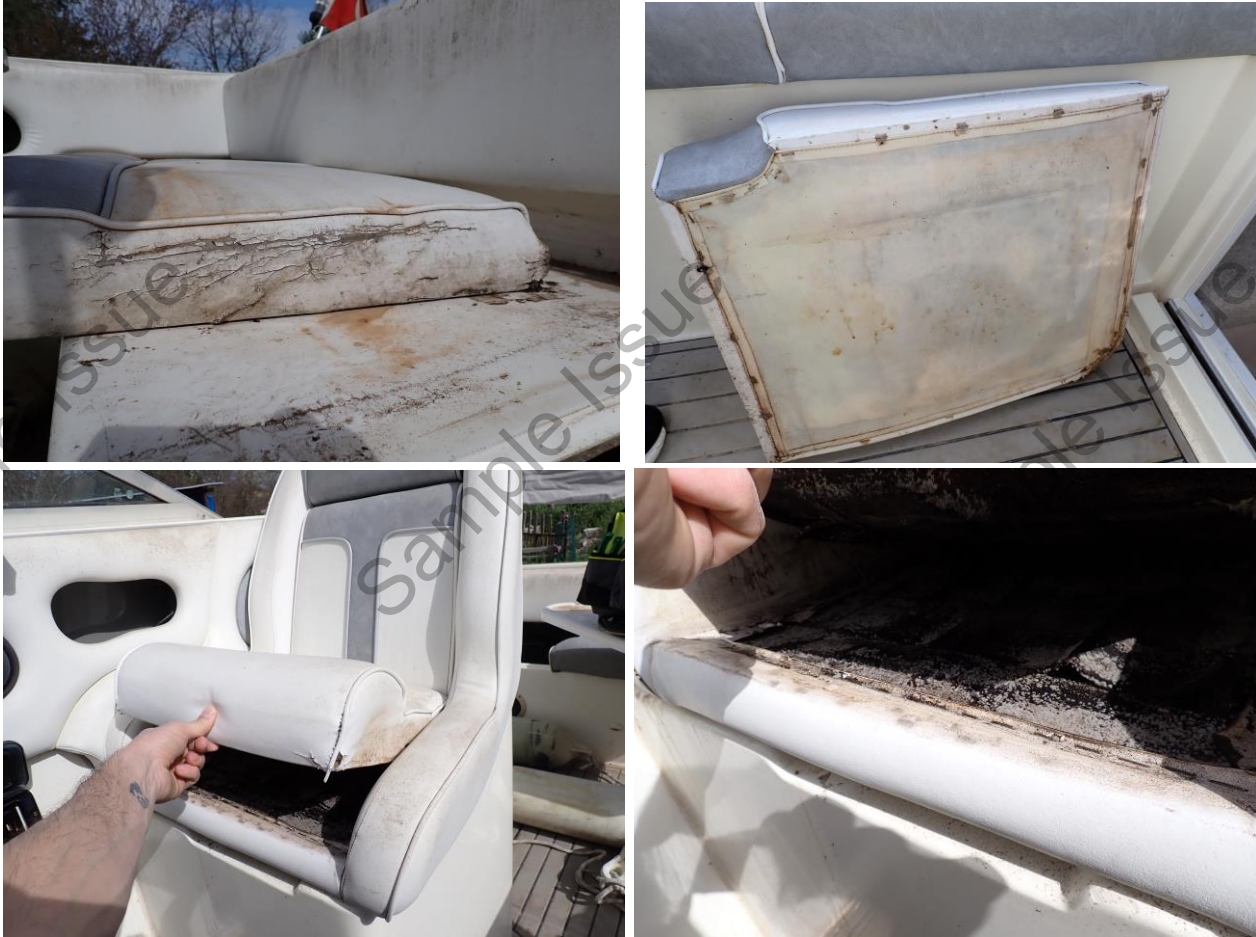
The exterior cockpit upholstery and seating arrangements were visually inspected and found to be heavily degraded due to age, UV exposure, and environmental weathering. The marine vinyl is severely cracked, brittle, and split across multiple cushions, particularly along the forward edges of the bench seating and the stress points of the folding bolster seat. There is pervasive mould, mildew, and environmental dirt ingrained in the material and along the seams, indicating the vessel has likely been stored without an adequate full-cover or regular maintenance. Inspection of the cushion undersides revealed rusted upholstery staples and significant water staining on the backing boards. Lifting the cushions revealed heavy accumulations of dirt, organic debris, and granular deposits (potentially degraded foam, heavy salt, or environmental debris) trapped in the recesses. This indicates that water has been pooling in these areas without properly draining.

Upholstery Renewal: The exterior cushions have exceeded their serviceable lifespan and require complete replacement or professional re-upholstery.

**Deep Cleaning & Drainage:** Prior to installing new cushions, all underlying seating bases, storage lockers, and associated drainage channels must be thoroughly cleaned and cleared of debris to prevent future moisture trapping and structural degradation.

**Fastener Upgrade:** Ensure any new upholstery is secured using marine-grade stainless steel (Monel) staples to prevent a recurrence of rust bleeding.

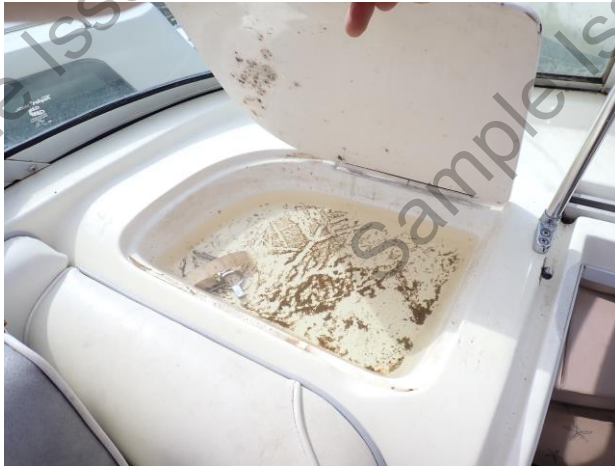
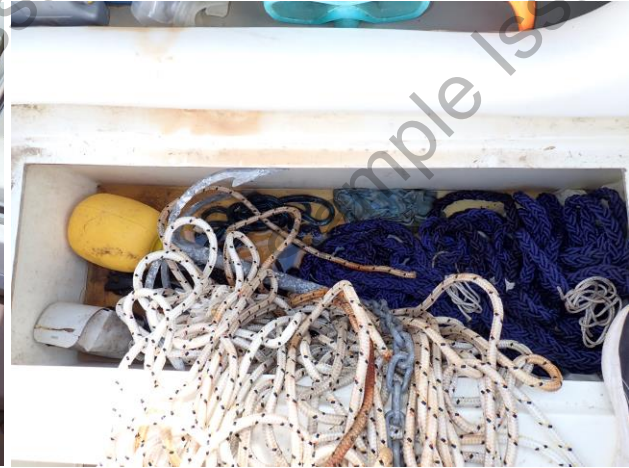
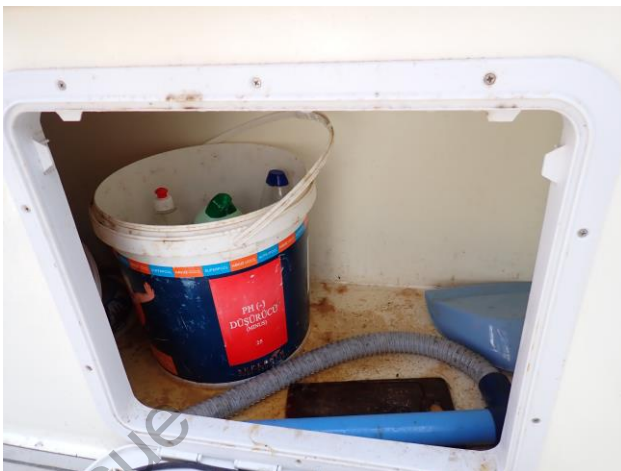
Inspection of the exterior cockpit and under-seat storage lockers revealed significant accumulations of standing water, dirt, and environmental debris. This is primarily attributed to rainwater ingress from a severely deteriorated exterior boat cover. While the failing cover is the source of the water, the retention of this water indicates a secondary issue. Properly functioning exterior lockers should self-drain. The standing water demonstrates that the locker drains or scuppers are heavily clogged with debris or inadequately sized. The aft port side locker containing the ground tackle (anchor, chain, and rode) is completely flooded. Prolonged submersion in standing water will rapidly accelerate the corrosion of the

galvanized chain and the degradation/rot of the nylon rode. Conversely, the interior storage compartments located beneath the carpeted sole were inspected and found to be clean, dry, and free of moisture at the time of the survey.

**Weatherproofing:** Repair or renew the vessel's exterior mooring cover to immediately halt rainwater intrusion.

**Clear Drainage:** Empty all exterior lockers and physically clear all drain holes and scuppers of dirt and debris to restore proper water egress.

**Ground Tackle Maintenance:** Remove all ground tackle from the flooded locker. Allow the ropes to dry fully, inspect the chain for excessive rust, and thoroughly clean the interior of the locker before restowing the equipment.

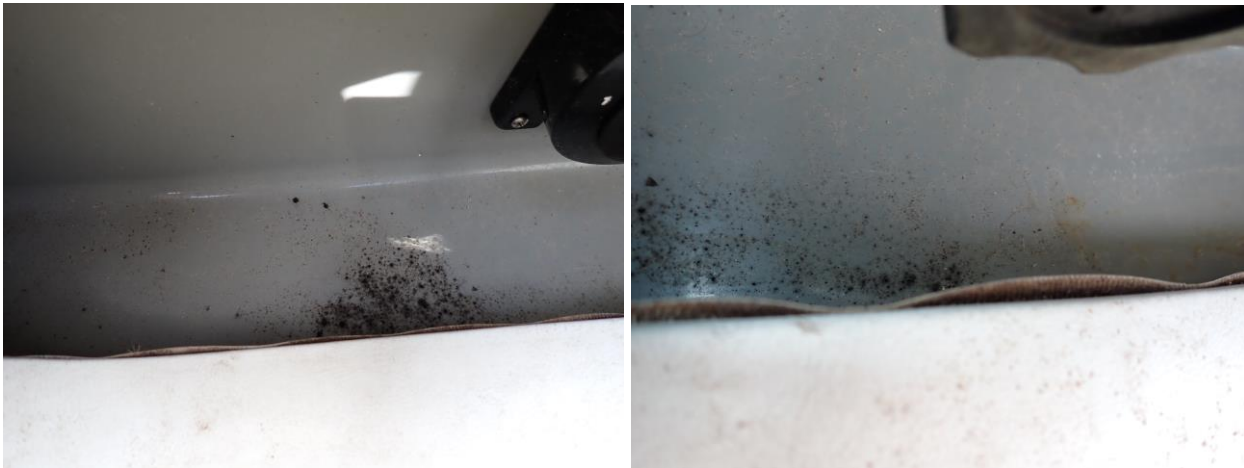
The small, open fiberglass (FRP) storage recesses integrated into the cockpit interior are structurally sound without visible cracking. However, there is a noticeable accumulation of ingrained dirt and dried environmental debris pooled at the bottom of each compartment, directly resulting from the failed exterior cover. The textile/vinyl upholstery on the interior coaming panels adjacent to these storage areas is actively separating from the underlying fiberglass (GRP) substrate. This delamination is a clear indication of adhesive failure, likely accelerated by prolonged heat, UV exposure, and moisture intrusion.

**Upholstery Repair:** Re-adhere the separating vinyl panels to the GRP substrate using a high-heat, marine-grade contact adhesive. If the vinyl material has shrunk significantly or the backing is too degraded to hold glue, the affected panels will require professional reupholstery.

**Deep Cleaning:** Thoroughly clean and wash out the interior surfaces of all open storage cubbies to remove the accumulated debris and prevent permanent staining of the white gelcoat.

**Moisture Management:** As these compartments do not self-drain, extra care should be taken not to stow items sensitive to standing water until the vessel's exterior mooring cover is renewed to keep the interior dry.

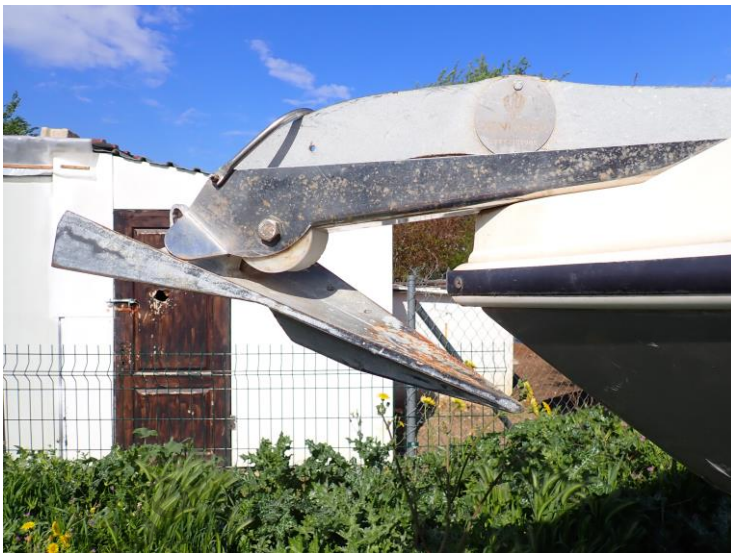
Denissea brand main anchor with serial number 08ST2105005 is a galvanized Danforth style (fluke) anchor, stowed on the bow roller. It is appropriately secured with a secondary safety lashing to the adjacent deck cleat, which is good practice to prevent accidental deployment while underway. The galvanizing on the anchor is degrading. There is moderate surface rust visible, particularly in high-friction areas such as the leading edges of the flukes, the pivot points at the crown, and along the shank where it rests against the bow roller. The anchor is attached to the galvanized chain rode via a standard shackle. Similar to the anchor, the shackle and the visible links of the chain are exhibiting surface rust.

Corrosion Treatment: Wire brush the rusted areas of the anchor, shackle, and chain to remove loose scale, and treat with a cold-galvanizing spray (zinc-rich paint) to inhibit further corrosion. While currently structurally sound, if metal wastage becomes significant over time, replacement or professional hot-dip re-galvanizing will be required.

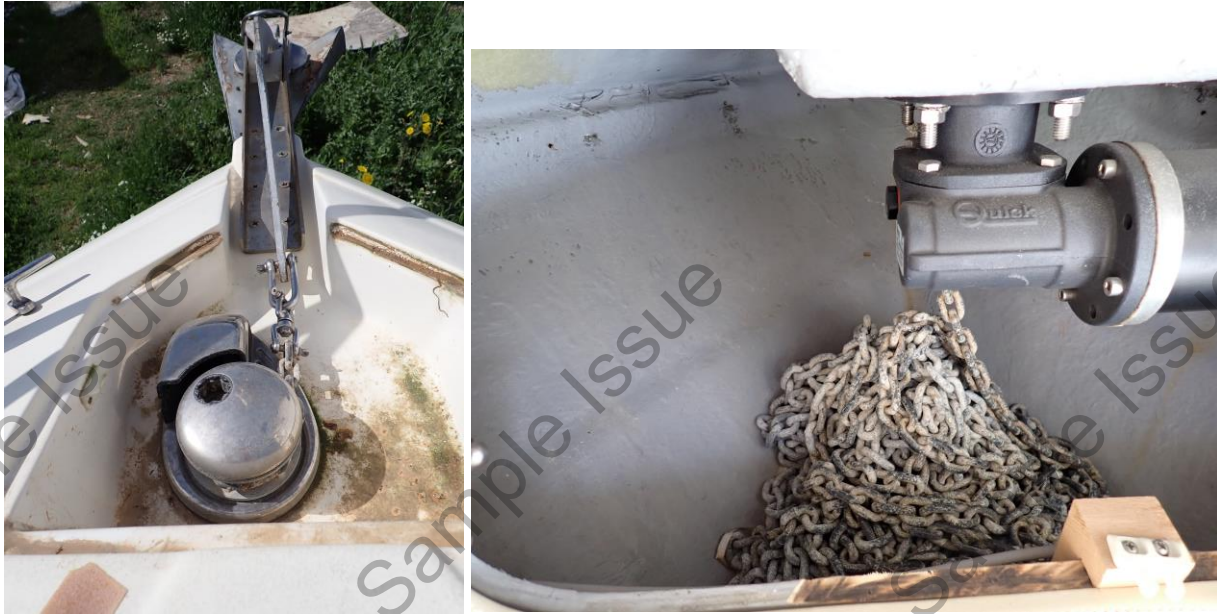
Quick CL1 512 / 500Watt / 12 volt with 6mm gypsy head. The motor is seated inside the chain locker reachable from the cabin in very good condition. Windlass gear on the bow is in good condition with some dirt and mould visible in the deck hatch, will possibly be easily cleaned off.

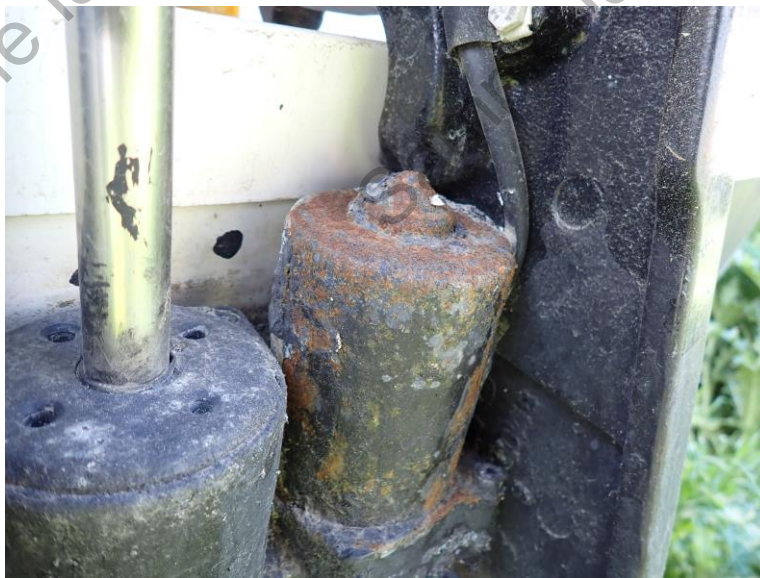
A significant observation was the heavy external corrosion present on the electric Power Trim and Tilt (PTT) motor casing. Due to its low position on the outboard bracket, this component is routinely exposed to spray, moisture, and occasional washdown immersion, making this deterioration common in marine use. However, the present level of corrosion warrants near-term operational testing under load, with particular attention to abnormal noise, slow movement, or water ingress through the cable gland area.

Should further deterioration continue, replacement of the PTT motor assembly may become necessary.

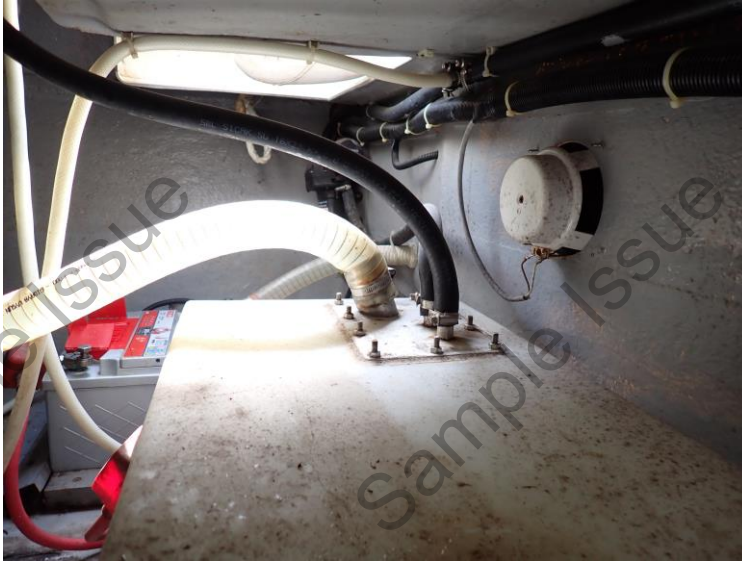
The primary concern within this system is the condition of the fuel supply hose clamps, several of which exhibit advanced corrosion and require immediate renewal using marine-grade stainless components.

At the base of one fuel hose connection, a localized accumulation of oily dirt and grime was noted. While no active dripping leak was present at the time of inspection, this residue is strongly suggestive of a minor chronic fuel weep or vapour seepage, likely originating from a compromised clamp seal or threaded fitting interface.

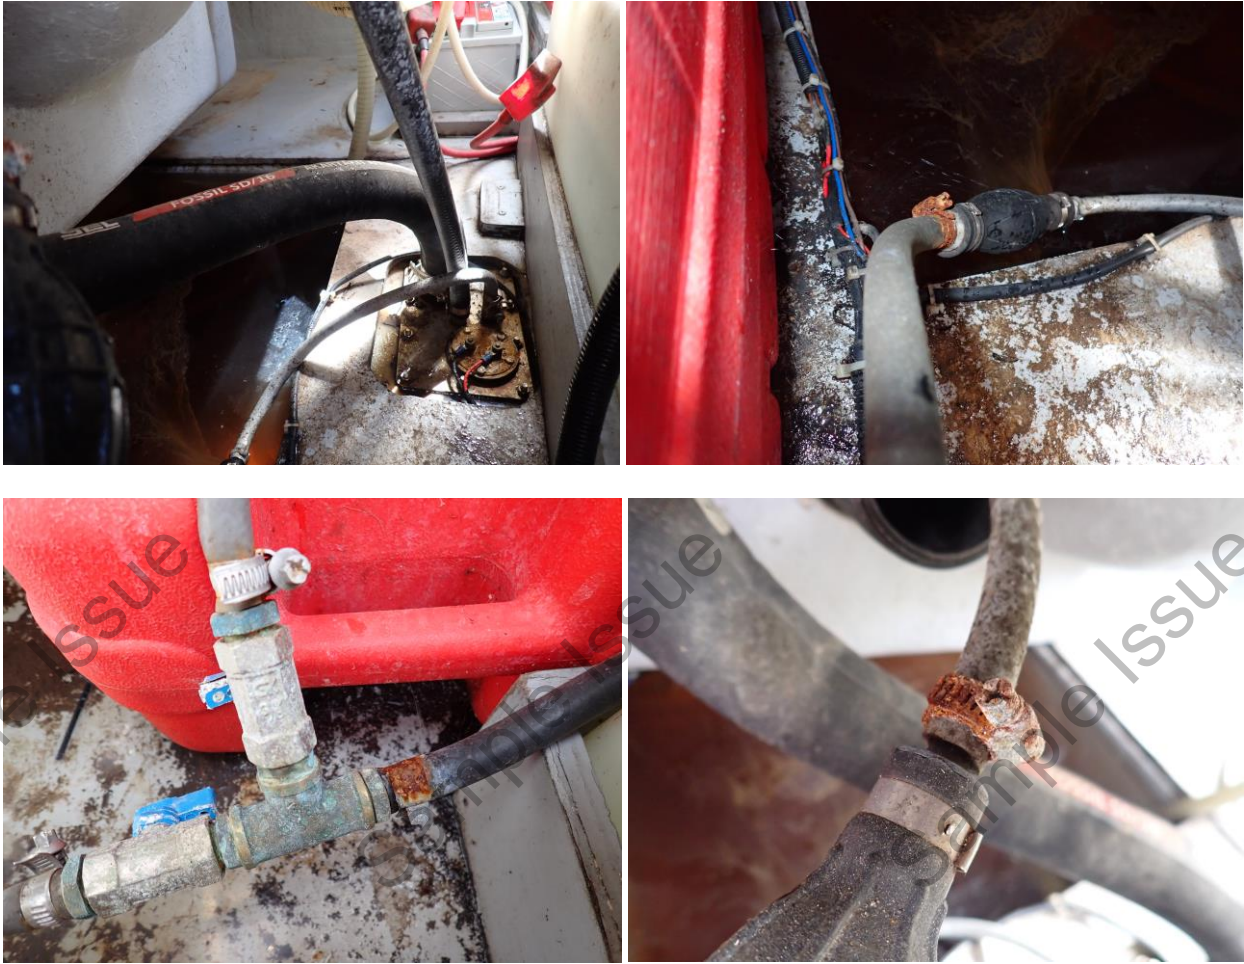
Proper hoses are fitted but the fuel hose clamps are heavily corroded and need to be replaced immediately. Base of the fuel hose exhibits an accumulation of oily grime and dirt. This buildup is characteristic of a slow, chronic fuel weep where vapour or minor liquid seepage attracts and traps environmental dust over time. While not actively dripping, it indicates the seal at the hose clamp or the threads of the fitting may be compromised. There is no visible dedicated bonding wire attached to the metal flange of the fuel level sending unit. While the plastic tank itself does not conduct electricity, isolated metal fittings within the fuel system must be grounded to safely dissipate static electricity generated during refueling.

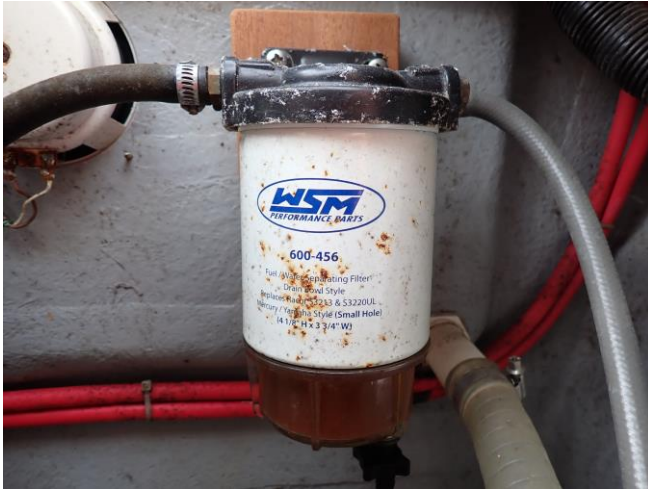
The bulkhead-mounted fuel/water separator filter (WSM “drain bowl” Mercury / Yamaha style (10 micron)) assembly remains installed and generally serviceable; however, the aluminium filter head exhibits white oxidation products consistent with marine atmospheric exposure. No service date or engine-hour marking was recorded on the filter canister, and this should be added as part of routine maintenance practice.

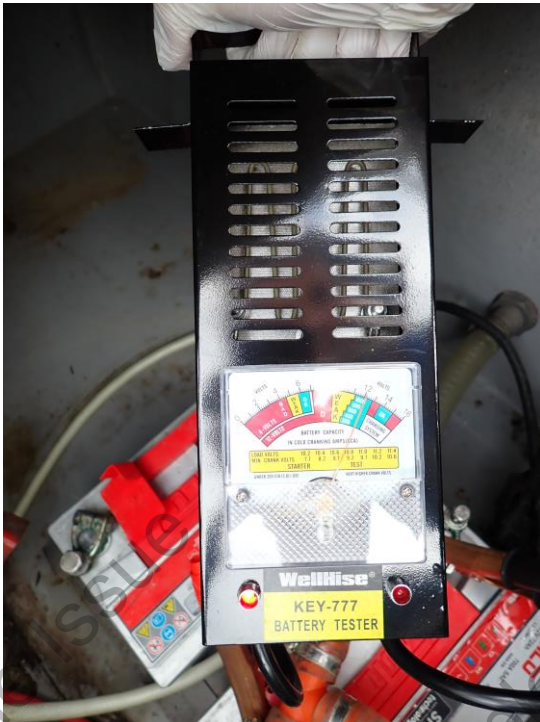
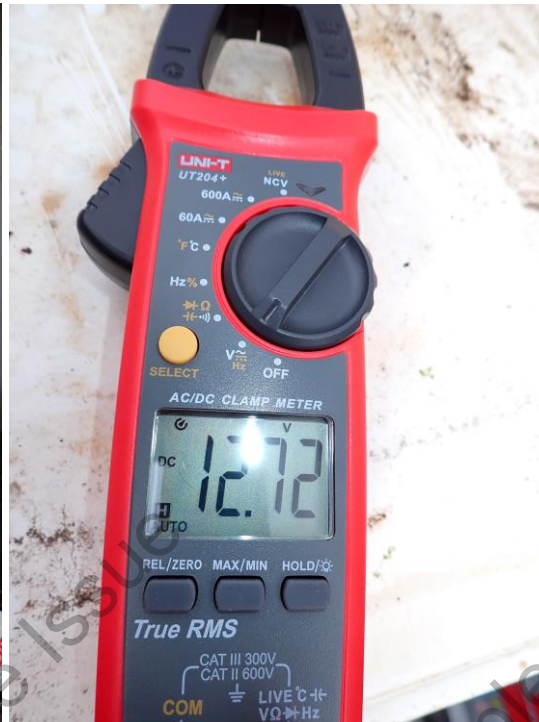
The vessel's DC system is based on a 12 V installation, supported by two Mutlu 12 V 72 Ah batteries, both of which had been intentionally disconnected for winter lay-up at the owner's instruction.

Static voltage checks indicated 12.63 V and 12.72 V respectively, while independent load testing suggested the batteries were slightly below optimum charge condition, although still consistent with recoverable lay-up discharge. Given that both batteries were reportedly replaced during Summer 2025, their present condition is considered acceptable provided they are reconnected and fully recharged without undue delay.

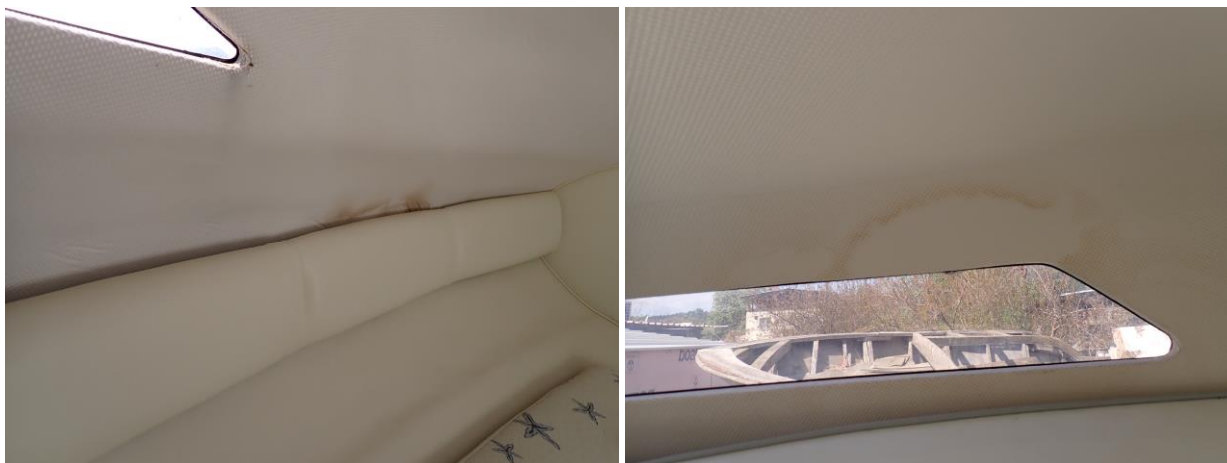
Two localized historical water staining areas remain visible within the cabin, specifically adjacent to the port window surround and behind the starboard backrest panel. The owner advised that the source of previous water ingress had been identified and rectified. At the time of survey, no active leakage was evident in these areas.

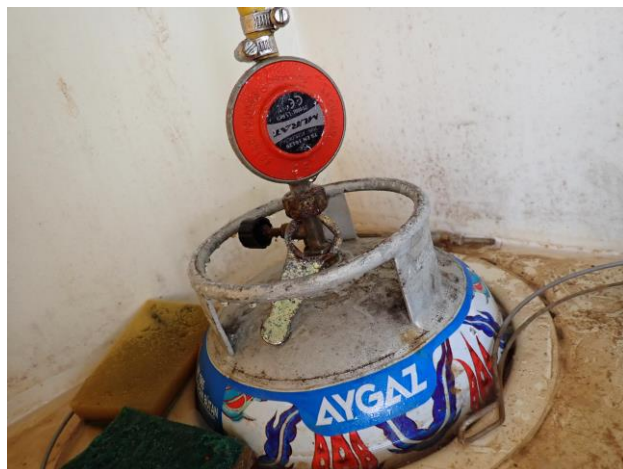
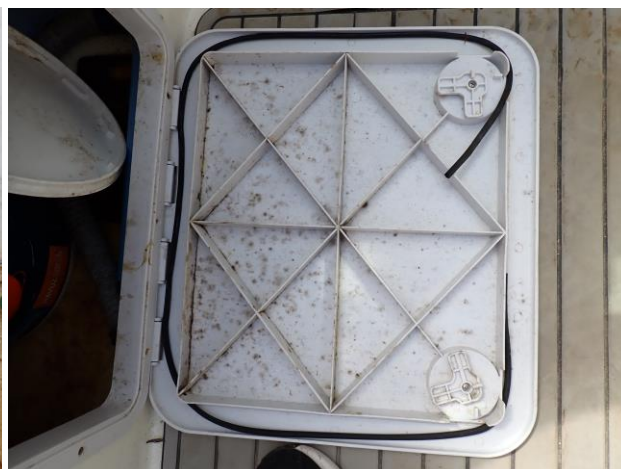
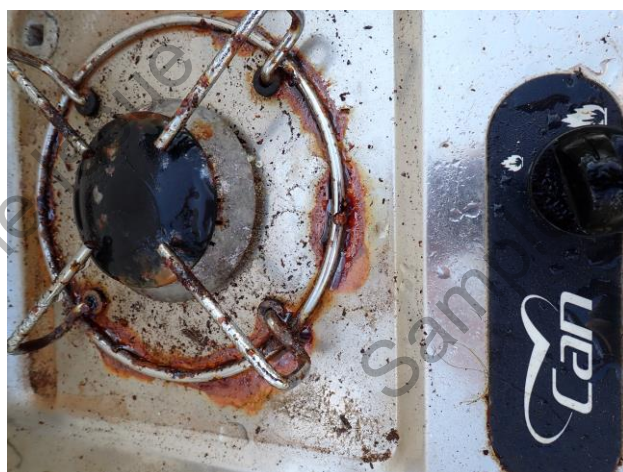
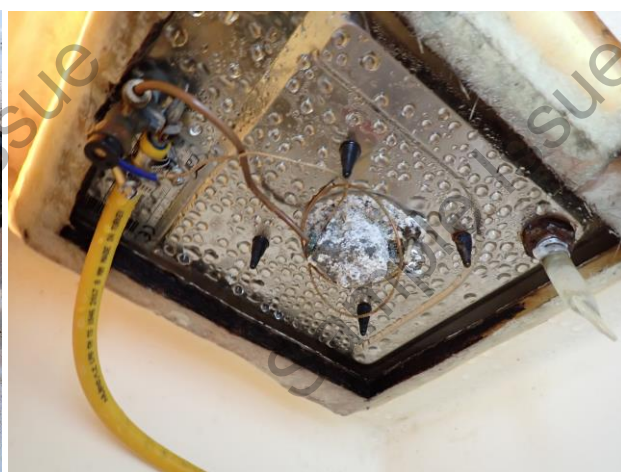
The LPG cylinder itself is retained within a recessed locker chamber and is physically stable in normal static condition, although no dedicated retaining strap or positive securing bracket was fitted, which should be fitted as a basic safety improvement.

Rainwater accumulation was present within the LPG locker, indicating either ineffective drainage or secondary water ingress from the deteriorated exterior cover. The underside of the LPG locker hatch cover exhibited visible mould spotting, dirt accumulation, and moisture staining, particularly along the gasket margin and reinforcement webs. This is consistent with prolonged damp conditions within the locker space and confirms inadequate ventilation and/or repeated rainwater ingress. The hatch cover and sealing gasket should be thoroughly cleaned, disinfected, and inspected for compression loss or discontinuity to ensure the locker remains as dry and vapour-tight as practicable. Particular concern is noted regarding the LPG regulator, which exhibits advanced corrosion and should be replaced immediately before further gas system use.

The stove assembly is heavily corroded and currently below desirable service condition, requiring either professional overhaul or full replacement before the vessel is returned to normal domestic use.

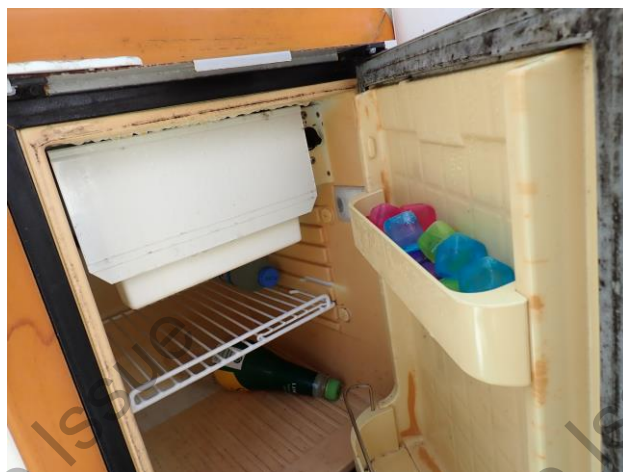
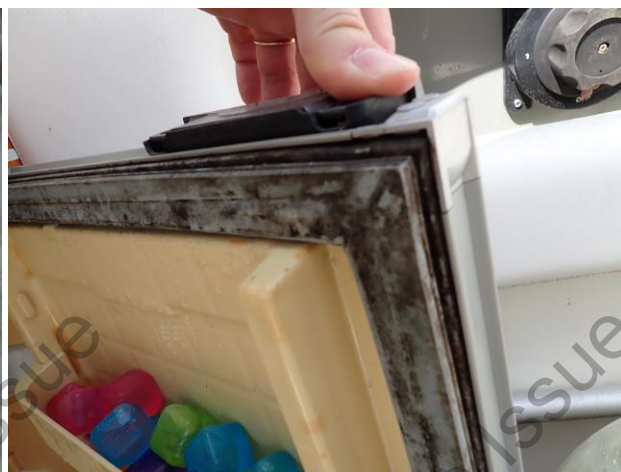
The compact cockpit refrigerator remains fitted and functional in principle, although mould growth was noted around the door sealing surfaces, indicating the need for sanitation cleaning and seal inspection.

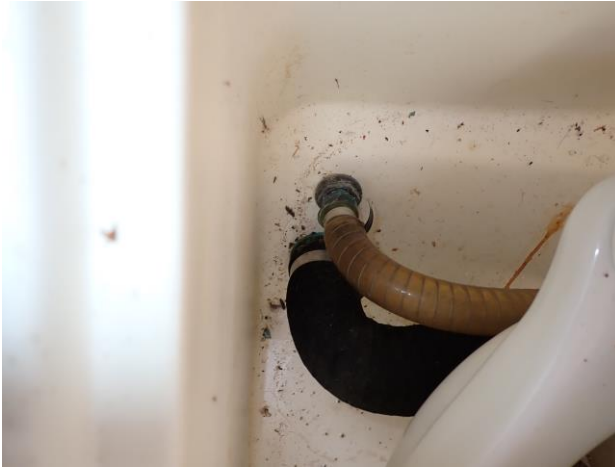
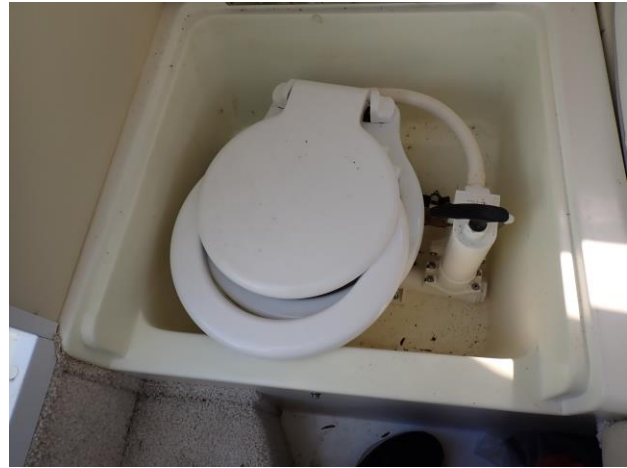
The toilet unit itself remains basically serviceable; however, the seat and lid hinge fittings are broken and require replacement.
