**LIMITED EXTERIOR HULL AND DECK CONDITION SURVEY REPORT**  
**FOR MOTOR YACHT “XXXXXXXXXX”**

Date of Survey: 05 April 2026

Location: Setur Marina/Antalya/Turkey (Boat yard)

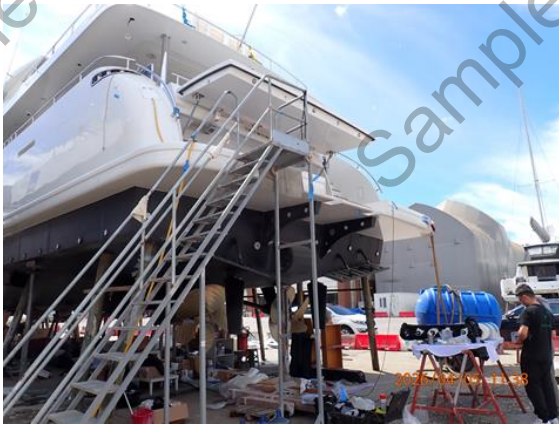
The transom structure was undergoing modification works associated with the installation of an enlarged swim platform arrangement. Construction activities were active at the time of inspection and therefore the final condition of this area could not be assessed.

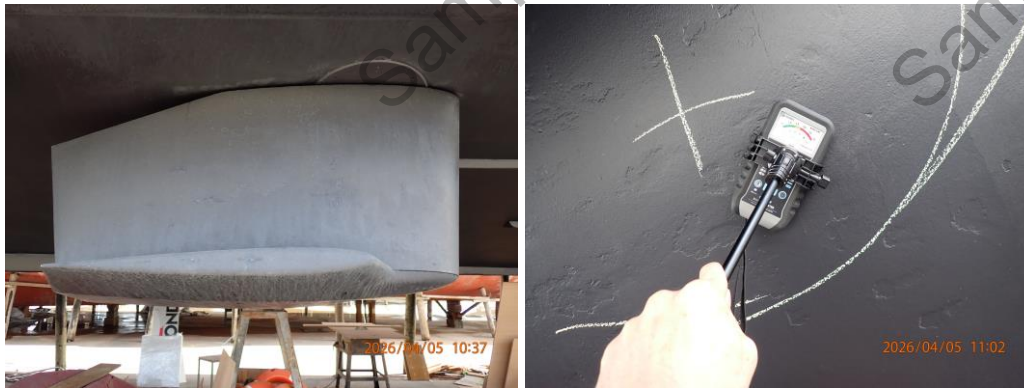
Moisture meter readings were taken extensively throughout the hull shell using a Tramex Skipper 5 moisture meter, supplemented by percussion sounding. Elevated readings were consistently recorded over large areas of the underwater hull, with values generally increasing from the forward

sections toward the aft body. Percussion sounding broadly correlated with these findings, producing comparatively duller responses in the higher-reading areas.

Particular significance is attached to these observations because the vessel had reportedly been ashore for an extended period prior to inspection rather than being recently hauled out. Consequently, residual surface moisture associated with recent immersion is considered less likely to be the sole cause of the elevated readings.

It should be emphasized that moisture meter readings alone do not constitute evidence of structural deterioration, timber decay, laminate failure, or delamination. The vessel's construction method, coating systems, timber content, metallic reinforcement, and local laminate thickness variations can all influence moisture meter response. No visible symptoms of structural failure, distortion, movement, coating breakdown, or timber degradation were identified during this inspection.

Nevertheless, the overall moisture profile observed is considered worthy of continued monitoring. Future haul-out inspections should include comparative moisture mapping, particularly in way of the aft hull sections, stabilizer foundations, underwater lighting penetrations, and through-hull fittings. Should moisture readings continue to increase over time, more invasive investigation methods may be warranted.

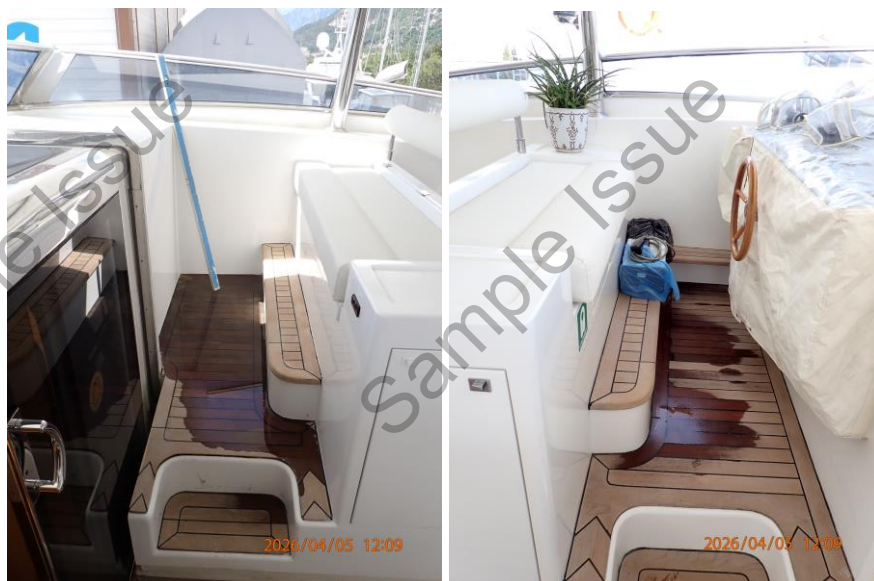
Moisture meter readings were taken throughout accessible deck areas using a Tramex Skipper 5 moisture meter. Elevated readings were recorded in various locations on the flybridge deck and in way of the overhead structure above the exterior seating area. Certain localized areas also exhibited evidence of standing rainwater accumulation.

As with the hull moisture survey findings, moisture meter readings alone do not confirm structural deterioration. However, given the vessel's construction method and the persistence of elevated readings after a prolonged period ashore, these areas warrant continued monitoring and further investigation during future maintenance periods.

No visible signs of laminate cracking, deck deflection, surface distortion, or structural movement were observed in association with the elevated readings at the time of inspection.

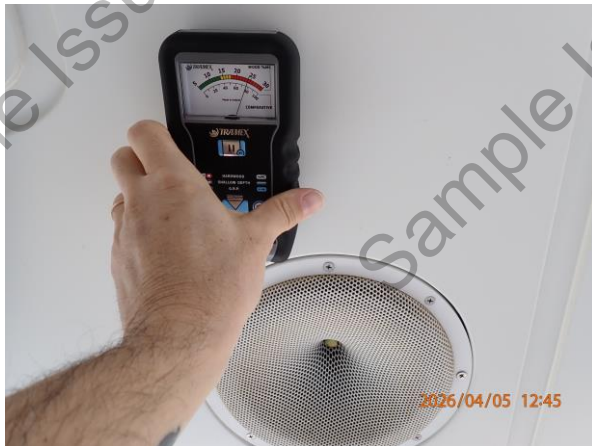
Exterior seating arrangements were generally found in good cosmetic and structural condition. Elevated moisture readings were recorded within portions of the overhead structure above the exterior seating area. No associated cracking, distortion, or visible structural deterioration was observed during inspection.

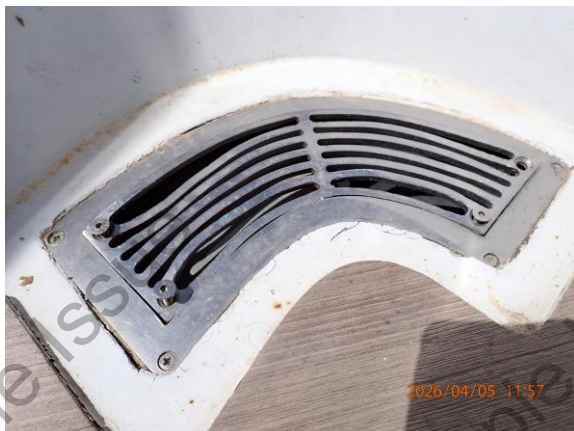
Deck drainage arrangements were generally satisfactory. One washdown fitting located forward was found damaged and should be repaired or replaced during the next maintenance period. All other inspected washdown and drainage fittings appeared serviceable.

One forward washdown fitting was found damaged. Repair or replacement is recommended during routine maintenance.

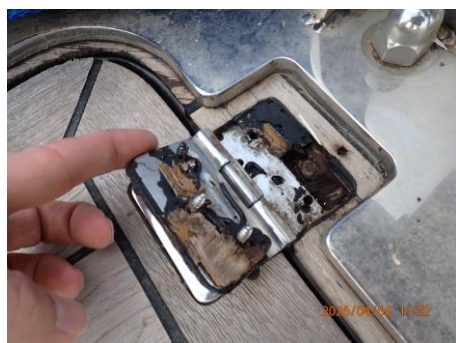
One deficiency was noted within the anchor locker, where the hatch hinge was found damaged. While not considered a safety-critical defect, repair is recommended to prevent further deterioration and to maintain safe access to the locker space.

The anchor locker hatch hinge was found damaged. Repair is recommended to maintain safe access and prevent progressive deterioration.

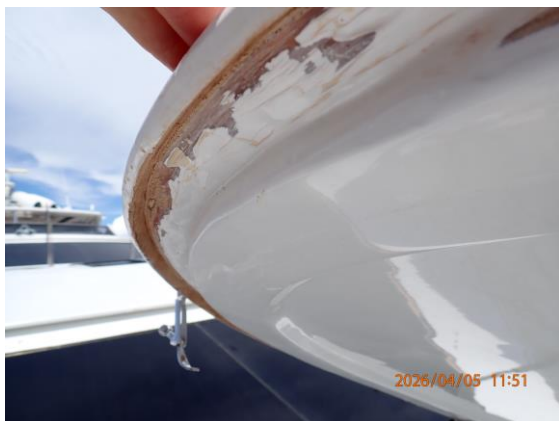
One exterior storage locker located forward was found to have a deteriorated cover. Although this does not presently affect structural integrity, renewal is recommended to prevent progressive weather-related degradation and moisture ingress.

The cover of one forward storage locker exhibited deterioration associated with weather exposure. Renewal is recommended during future maintenance works.
