## IIMS ASSIGNMENT 4 TASK 5A

### SAMPLE CONDITION SURVEY REPORT FOR 7M GRP MOTOR CRUISER

Date of Survey: April 2026

Location: İzmir Region (Haul-out yard)

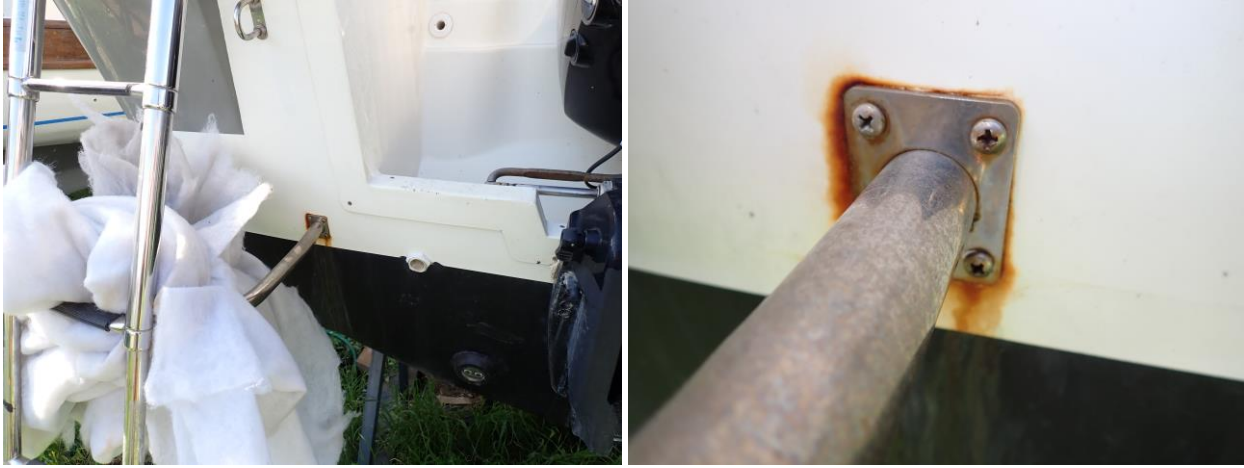
Small swim platform next to the outboard engine, also used as the ladder storage. The stainless steel tubular supports for the swim ladder/step are secured directly to the vessel's transom. The tubular stainless steel itself appears structurally intact, though it shows minor surface staining. There is distinct rust weeping (iron oxide staining) bleeding down the transom fiberglass from behind the circular mounting flanges. This strongly indicates that the hidden fasteners securing the mounts to the hull are actively corroding. This is typically caused by the use of non-marine grade fasteners (e.g., lower-grade stainless or galvanized steel) or crevice corrosion due to failed bedding compound allowing moisture to become trapped.

**Fastener Renewal:** Remove the mounting hardware and extract the corroding fasteners.

**Cosmetic Repair:** Clean the rust staining from the surrounding transom gelcoat/fiberglass using a specialized rust remover (such as an oxalic acid-based cleaner).

**Re-bedding:** Secure the fittings using new, properly sized marine-grade (316) stainless steel fasteners. Critically, the fittings must be thoroughly re-bedded with a high-quality marine sealant to prevent future moisture intrusion into the transom structure.

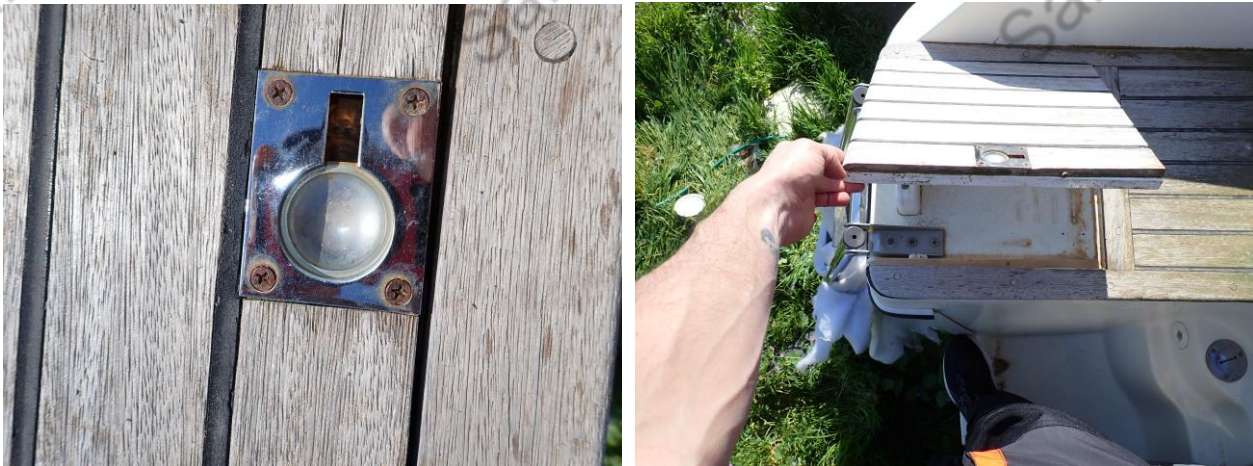
The stainless-steel hinges for the fold-down boarding ladder appear to be in good condition, though minor surface staining is visible. The storage flush ring catch is broken, and four screws securing it are heavily rusted, indicating they are likely not marine-grade 316 stainless steel (they may be mild steel, galvanized, or a low-grade stainless). The white fiberglass gutter/recess beneath the hatch shows distinct brown rust staining. This is a direct result of water washing over the corroded screws on the catch and depositing iron oxide into the drain area.

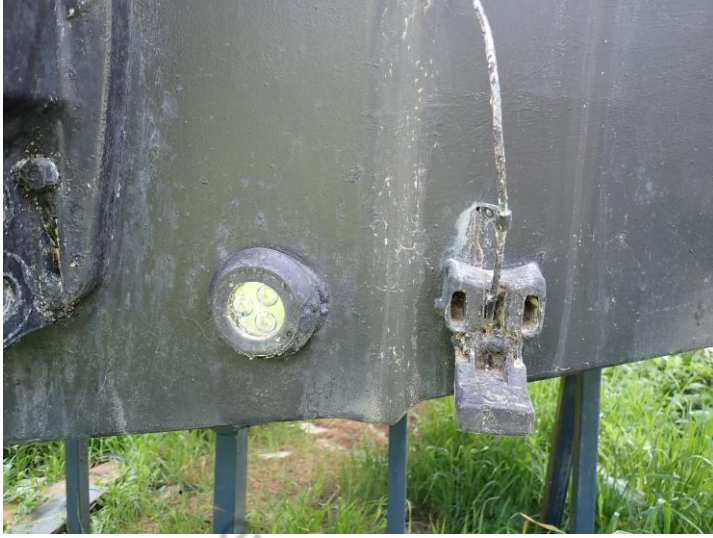
## Transducers

Painted. Should not have been painted. The transducer face itself remains uncoated; however, full functional verification should be carried out when the vessel is afloat.

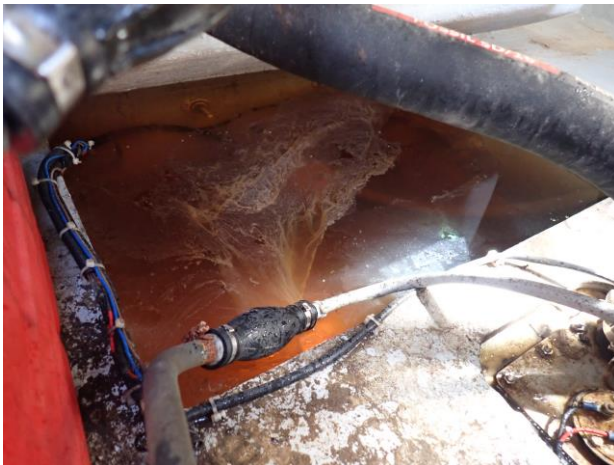
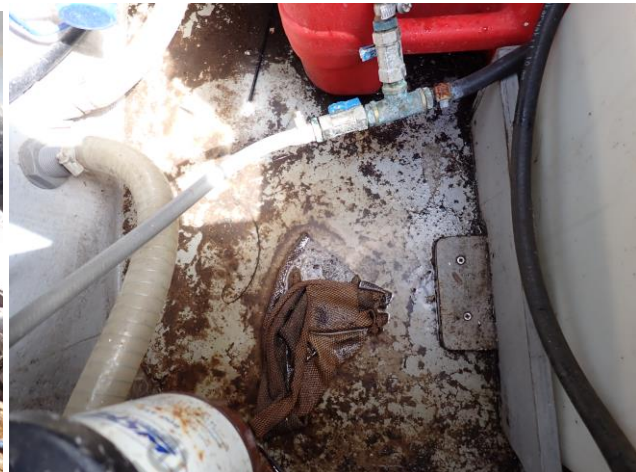
## Percussion Sounding and Moisture Reading

No sign of moisture detected on the exterior of the hull except on the aft close to the transom. When inspected from the inside, water was found in the interior of the transom, inside the aft bilge. There is a bilge pump inside but because the batteries are disconnected the pump is not operated.

The water observed in many areas such as the bilges, the storages and the moist cockpit sitting cushions are because of the boat's heavily deteriorated top cover, which allows the rainwater in.

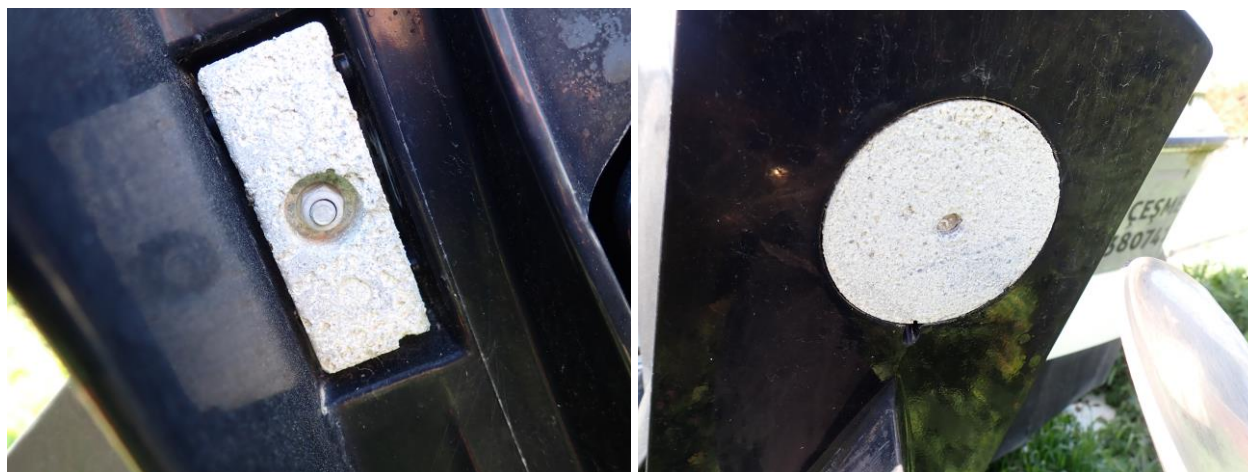
## Anodes by Zone

2 outboard motor anodes are depleted and need to be replaced

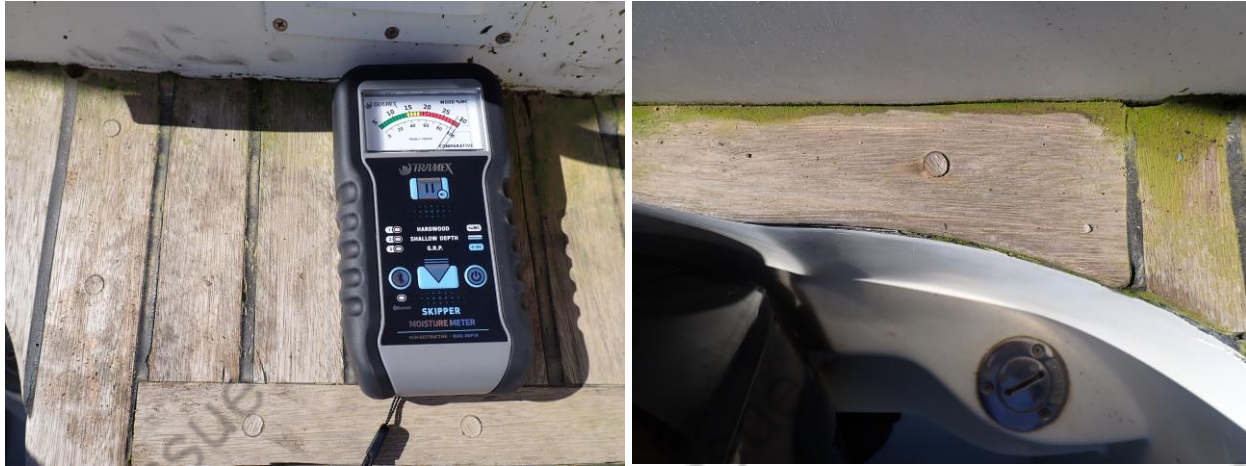
along the forward edge/lip of the wooden hatch. This indicates moisture retention in that area when the hatch is closed. On the stern of the boat, the “swim platform” area, the teak is weathered but appears structurally intact. However, the black caulking appears to be failing slightly, showing minor separation or degradation from the edge of the plank. There is green algae or moss visible along the inner edge where the teak meets the vertical white fiberglass surface. This indicates that water tends to pool or linger in this corner rather than draining away completely.

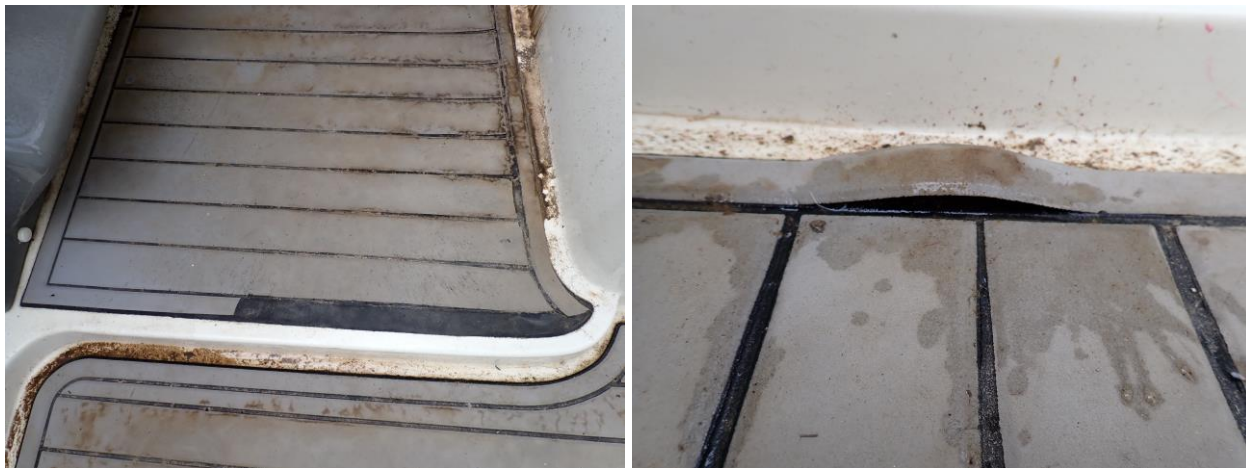
The synthetic soft-deck flooring in the cockpit sole area exhibited localized edge lifting and partial adhesive failure, particularly along the perimeter margin adjacent to the coaming return. Surface contamination, trapped moisture, and minor biological staining were also visible within the margin channels. The affected flooring section should be lifted locally, the substrate thoroughly cleaned and dried, and the material re-bonded or renewed as required using a marine-grade EVA deck adhesive system.

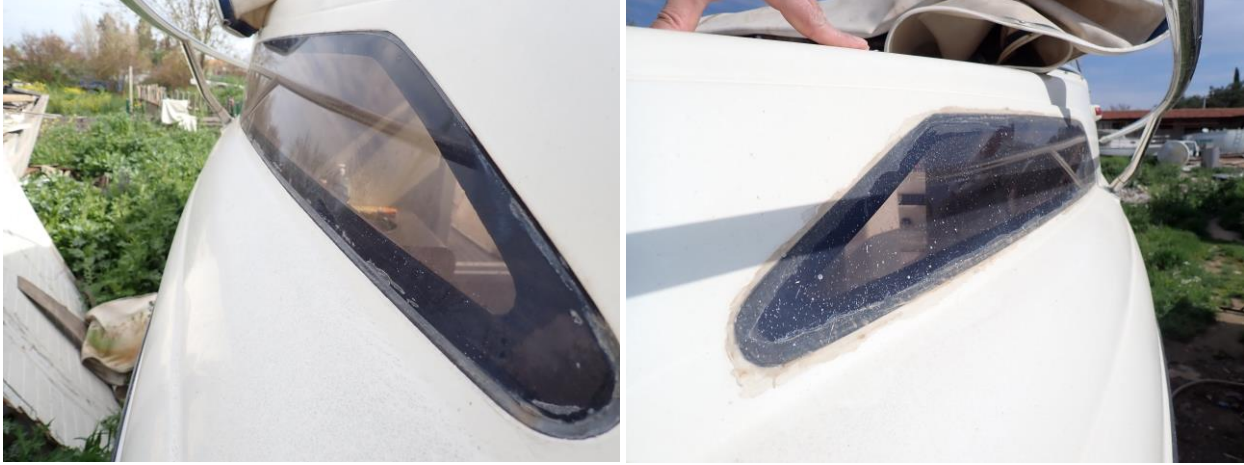
### Deck Hatches and Portholes:

In good condition but poor craftsmanship observed. Should be inspected regularly. Starboard cabin window looks like it was redone with silicone, possibly due to a leak.

- Re-bed starboard cabin window previously repaired with silicone.
- Clean and preserve teak surfaces and failing caulking margins.
- Inspect transducer performance afloat due to antifouling paint contamination.
- Renew mooring cover to prevent continued rainwater ingress.

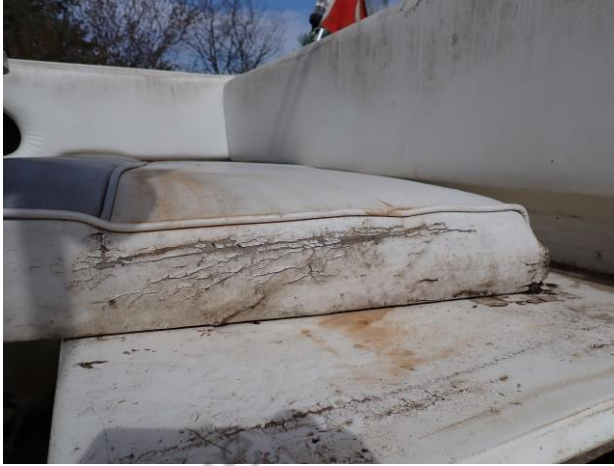
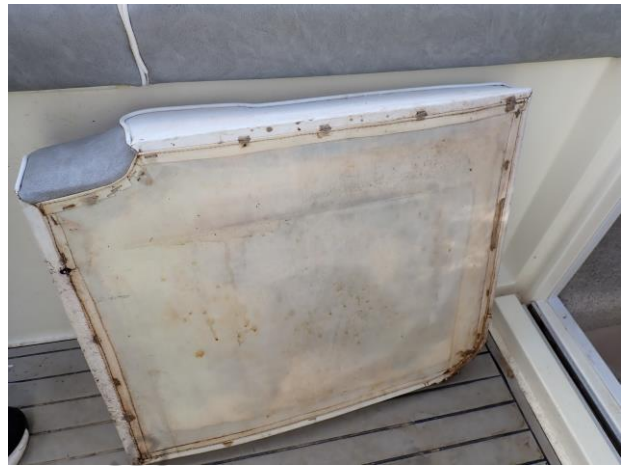
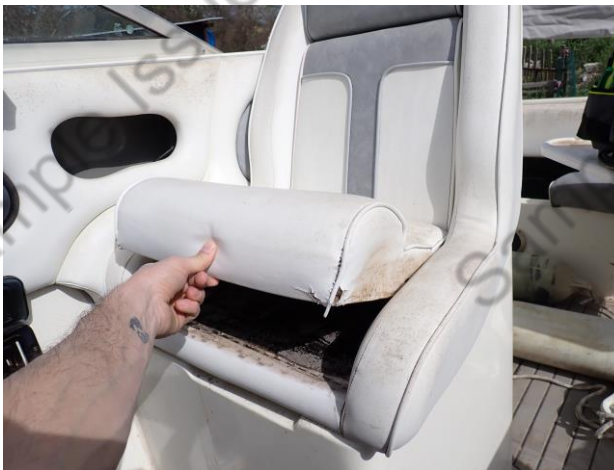
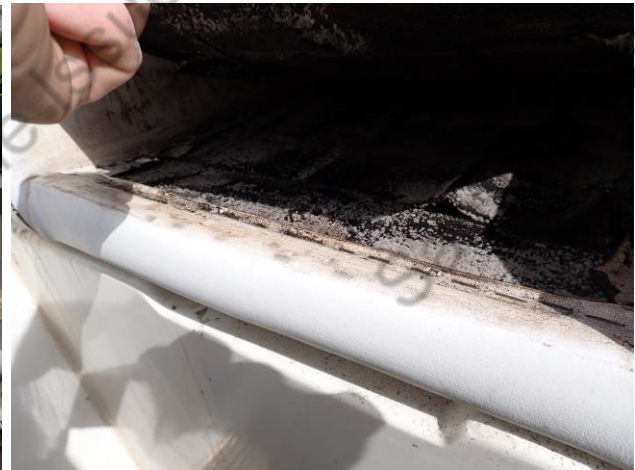
The exterior cockpit upholstery and seating arrangements were visually inspected and found to be heavily degraded due to age, UV exposure, and environmental weathering. The marine vinyl is severely cracked, brittle, and split across multiple cushions, particularly along the forward edges of the bench seating and the stress points of the folding bolster seat. There is pervasive mould, mildew, and environmental dirt ingrained in the material and along the seams, indicating the vessel has likely been stored without an adequate full-cover or regular maintenance. Inspection of the cushion undersides revealed rusted upholstery staples and significant water staining on the backing boards. Lifting the cushions revealed heavy accumulations of dirt, organic debris, and granular deposits (potentially degraded foam, heavy salt, or environmental debris) trapped in the recesses. This indicates that water has been pooling in these areas without properly draining.

Upholstery Renewal: The exterior cushions have exceeded their serviceable lifespan and require complete replacement or professional re-upholstery.

**Deep Cleaning & Drainage:** Prior to installing new cushions, all underlying seating bases, storage lockers, and associated drainage channels must be thoroughly cleaned and cleared of debris to prevent future moisture trapping and structural degradation.

**Fastener Upgrade:** Ensure any new upholstery is secured using marine-grade stainless steel (Monel) staples to prevent a recurrence of rust bleeding.

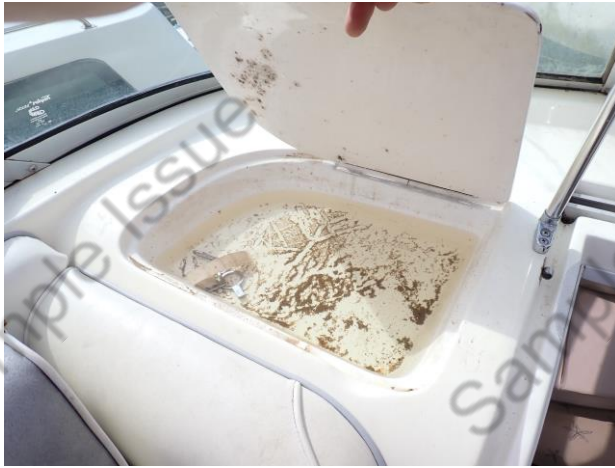
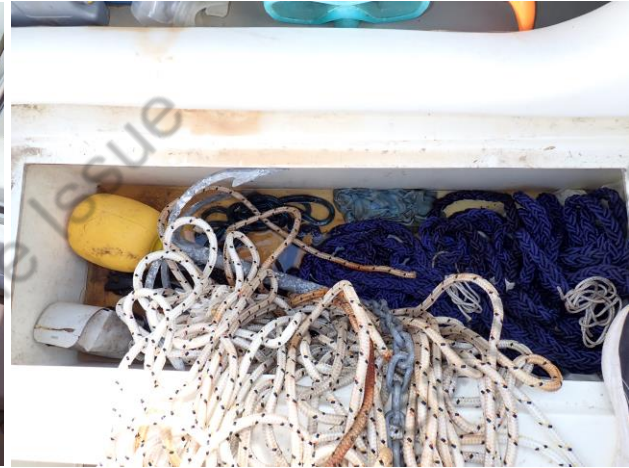
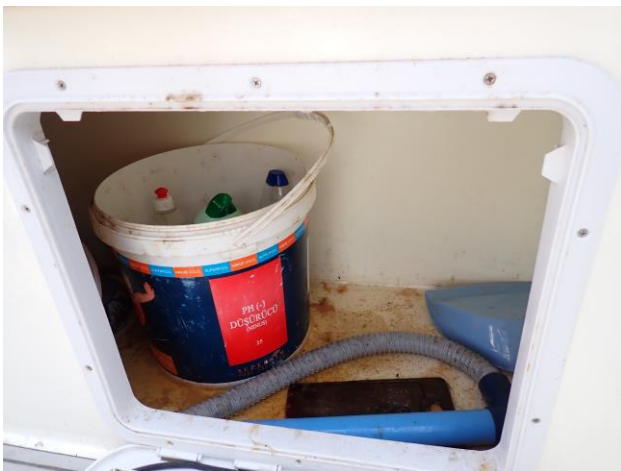
## Exterior Storage

Inspection of the exterior cockpit and under-seat storage lockers revealed significant accumulations of standing water, dirt, and environmental debris. This is primarily attributed to rainwater ingress from a severely deteriorated exterior boat cover. While the failing cover is the source of the water, the retention of this water indicates a secondary issue. Properly functioning exterior lockers should self-drain. The standing water demonstrates that the locker drains or scuppers are heavily clogged with debris or inadequately sized. The aft port side locker containing the ground tackle (anchor, chain, and rode) is completely flooded. Prolonged submersion in standing water will rapidly accelerate the corrosion of the

galvanized chain and the degradation/rot of the nylon rode. Conversely, the interior storage compartments located beneath the carpeted sole were inspected and found to be clean, dry, and free of moisture at the time of the survey.

**Weatherproofing:** Repair or renew the vessel's exterior mooring cover to immediately halt rainwater intrusion.

**Clear Drainage:** Empty all exterior lockers and physically clear all drain holes and scuppers of dirt and debris to restore proper water egress.

**Ground Tackle Maintenance:** Remove all ground tackle from the flooded locker. Allow the ropes to dry fully, inspect the chain for excessive rust, and thoroughly clean the interior of the locker before restowing the equipment.

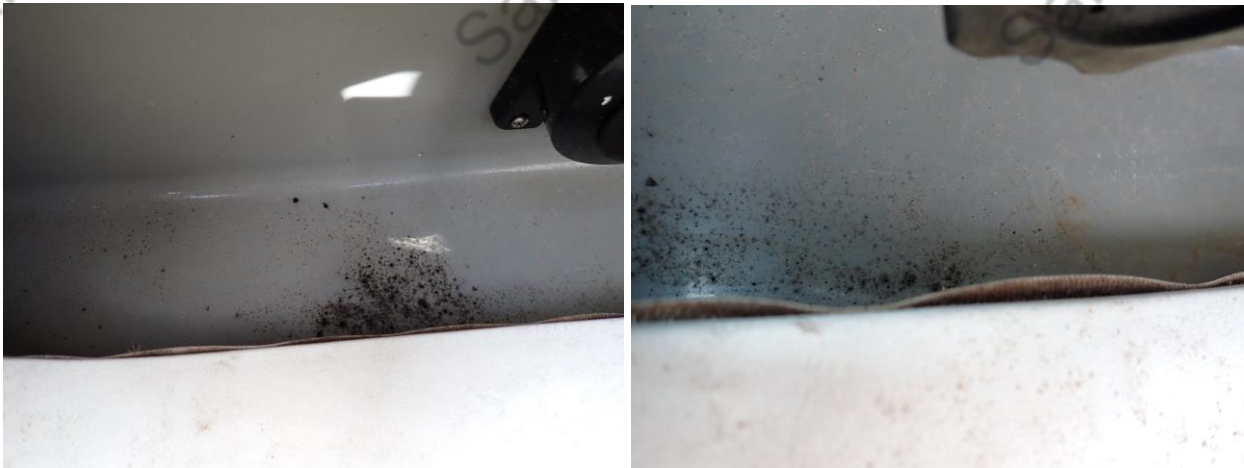
## Cockpit Open Storage

The small, open fiberglass (FRP) storage recesses integrated into the cockpit interior are structurally sound without visible cracking. However, there is a noticeable accumulation of ingrained dirt and dried environmental debris pooled at the bottom of each compartment, directly resulting from the failed exterior cover. The textile/vinyl upholstery on the interior coaming panels adjacent to these storage areas is actively separating from the underlying fiberglass (GRP) substrate. This delamination is a clear indication of adhesive failure, likely accelerated by prolonged heat, UV exposure, and moisture intrusion.

**Upholstery Repair:** Re-adhere the separating vinyl panels to the GRP substrate using a high-heat, marine-grade contact adhesive. If the vinyl material has shrunk significantly or the backing is too degraded to hold glue, the affected panels will require professional reupholstery.

**Deep Cleaning:** Thoroughly clean and wash out the interior surfaces of all open storage cubbies to remove the accumulated debris and prevent permanent staining of the white gelcoat.

**Moisture Management:** As these compartments do not self-drain, extra care should be taken not to stow items sensitive to standing water until the vessel's exterior mooring cover is renewed to keep the interior dry.

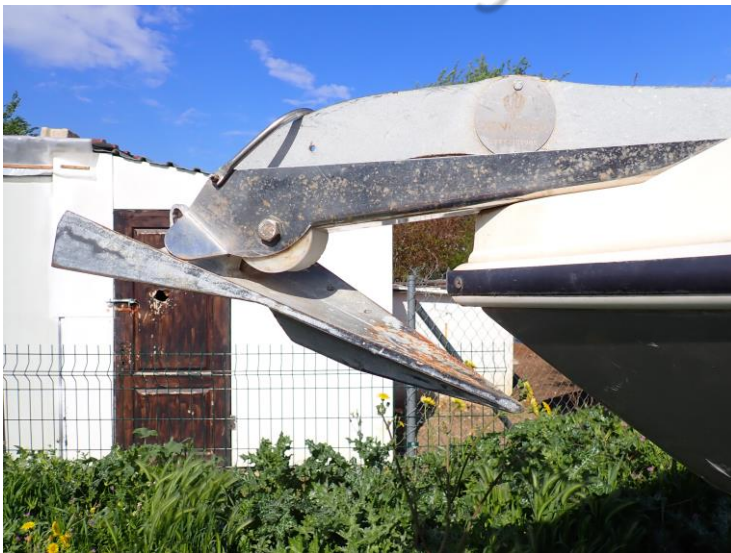
Denissea brand main anchor with serial number 08ST2105005 is a galvanized Danforth style (fluke) anchor, stowed on the bow roller. It is appropriately secured with a secondary safety lashing to the adjacent deck cleat, which is good practice to prevent accidental deployment while underway. The galvanizing on the anchor is degrading. There is moderate surface rust visible, particularly in high-friction areas such as the leading edges of the flukes, the pivot points at the crown, and along the shank where it rests against the bow roller. The anchor is attached to the galvanized chain rode via a standard shackle. Similar to the anchor, the shackle and the visible links of the chain are exhibiting surface rust.

Corrosion Treatment: Wire brush the rusted areas of the anchor, shackle, and chain to remove loose scale, and treat with a cold-galvanizing spray (zinc-rich paint) to inhibit further corrosion. While currently structurally sound, if metal wastage becomes significant over time, replacement or professional hot-dip re-galvanizing will be required.

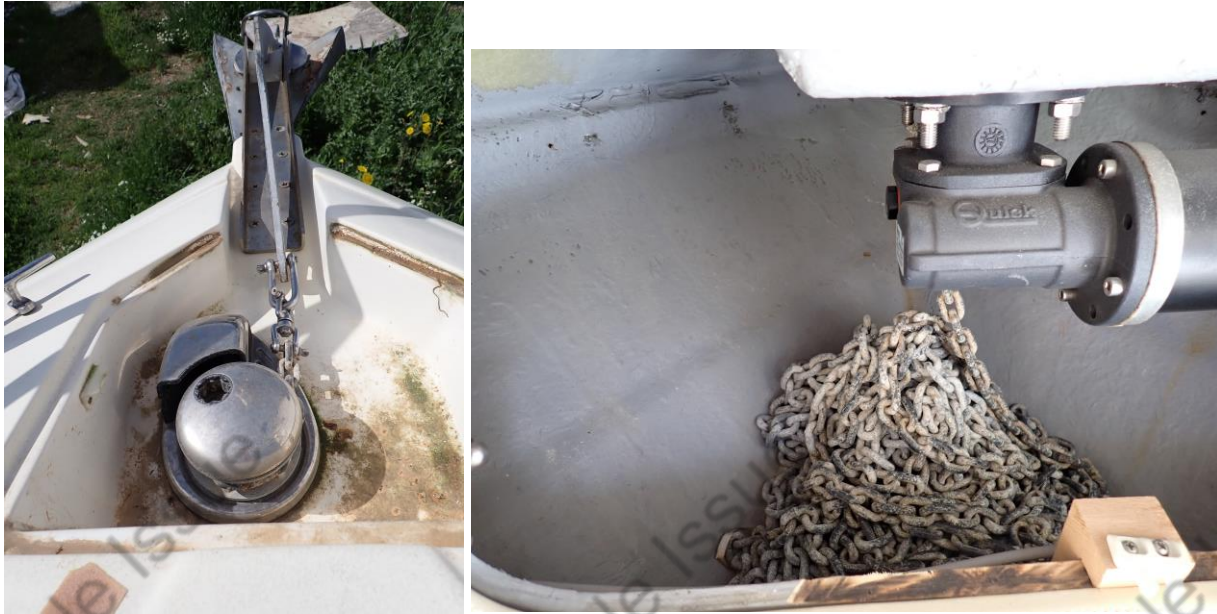
### Anchor windlass

Quick CL1 512 / 500Watt / 12 volt with 6mm gypsy head. The motor is seated inside the chain locker reachable from the cabin in very good condition. Windlass gear on the bow is in good condition with some dirt and mould visible in the deck hatch, will possibly be easily cleaned off.

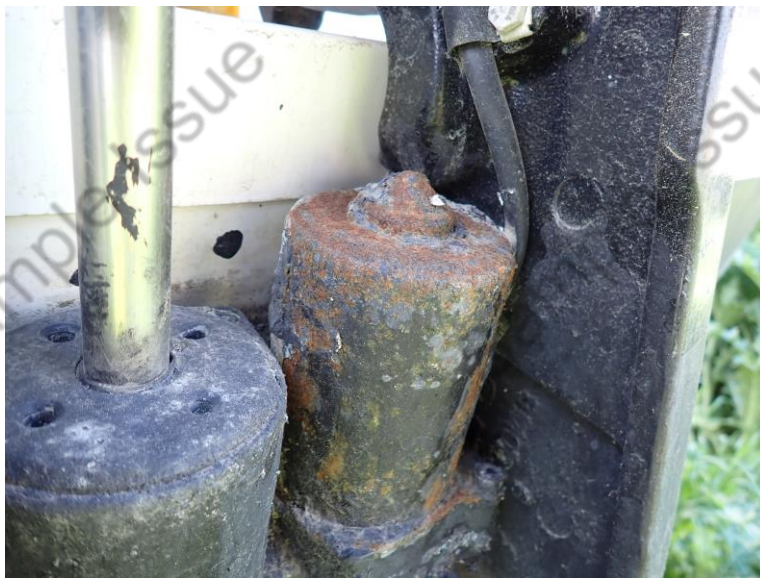
A significant observation was the heavy external corrosion present on the electric Power Trim and Tilt (PTT) motor casing. Due to its low position on the outboard bracket, this component is routinely exposed to spray, moisture, and occasional washdown immersion, making this deterioration common in marine use. However, the present level of corrosion warrants near-term operational testing under load, with particular attention to abnormal noise, slow movement, or water ingress through the cable gland area.

Should further deterioration continue, replacement of the PTT motor assembly may become necessary.

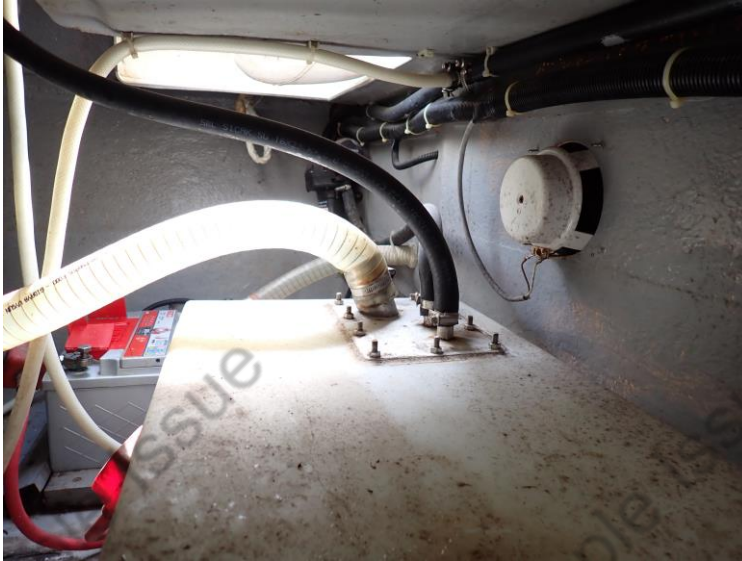
The primary concern within this system is the condition of the fuel supply hose clamps, several of which exhibit advanced corrosion and require immediate renewal using marine-grade stainless components.

At the base of one fuel hose connection, a localized accumulation of oily dirt and grime was noted. While no active dripping leak was present at the time of inspection, this residue is strongly suggestive of a minor chronic fuel weep or vapour seepage, likely originating from a compromised clamp seal or threaded fitting interface.

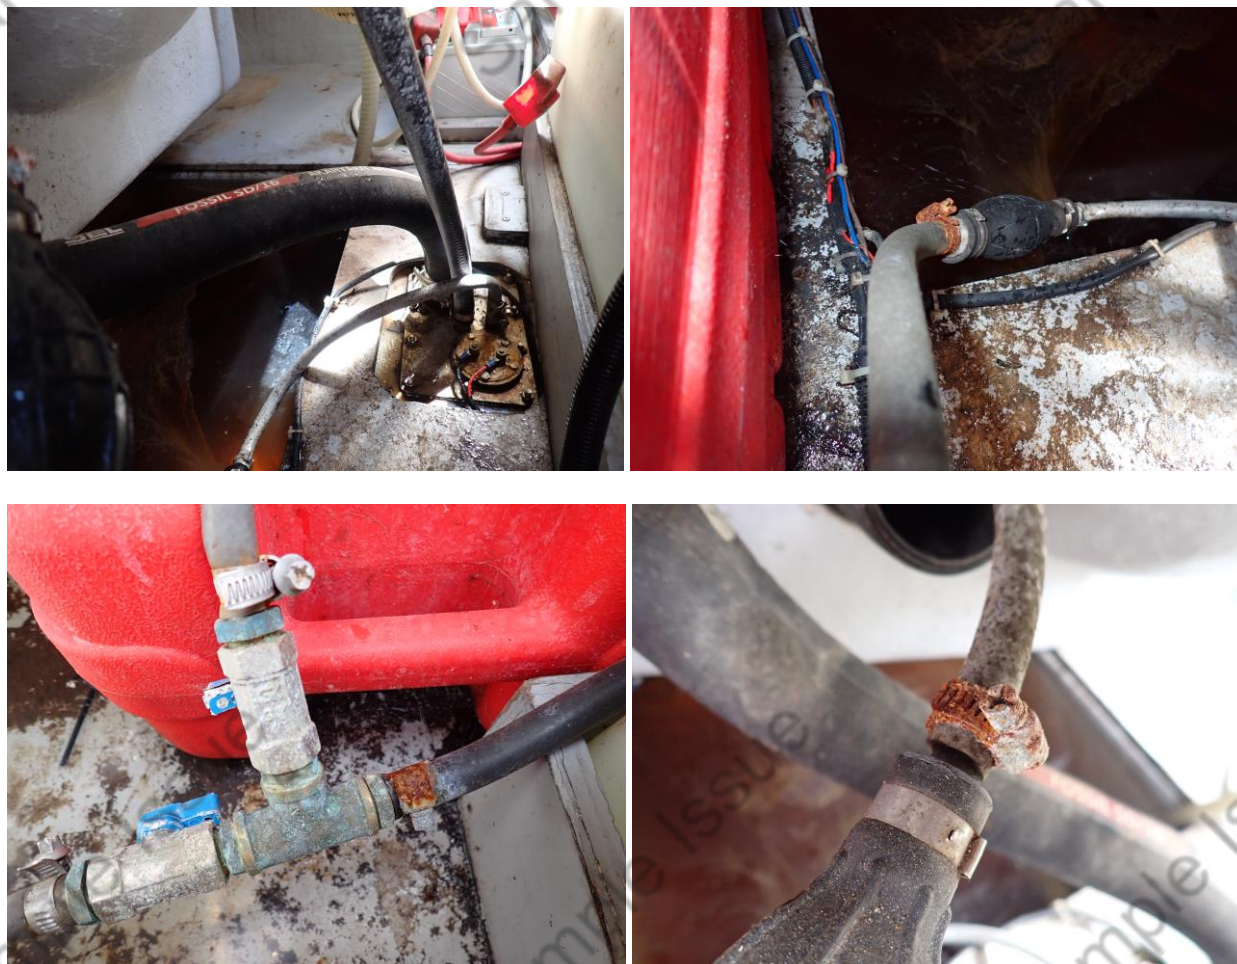
#### **Fuel supply lines/hoses:**

Proper hoses are fitted but the fuel hose clamps are heavily corroded and need to be replaced immediately. Base of the fuel hose exhibits an accumulation of oily grime and dirt. This buildup is characteristic of a slow, chronic fuel weep where vapour or minor liquid seepage attracts and traps environmental dust over time. While not actively dripping, it indicates the seal at the hose clamp or the threads of the fitting may be compromised. There is no visible dedicated bonding wire attached to the metal flange of the fuel level sending unit. While the plastic tank itself does not conduct electricity, isolated metal fittings within the fuel system must be grounded to safely dissipate static electricity generated during refueling.

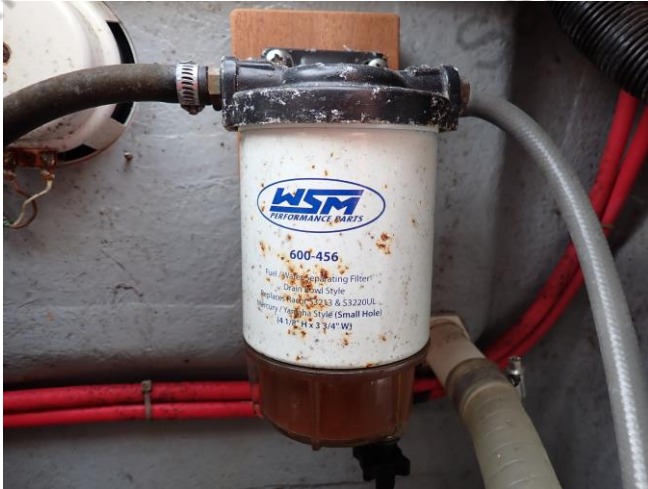
The bulkhead-mounted fuel/water separator filter (WSM “drain bowl” Mercury / Yamaha style (10 micron)) assembly remains installed and generally serviceable; however, the aluminium filter head exhibits white oxidation products consistent with marine atmospheric exposure. No service date or engine-hour marking was recorded on the filter canister, and this should be added as part of routine maintenance practice.

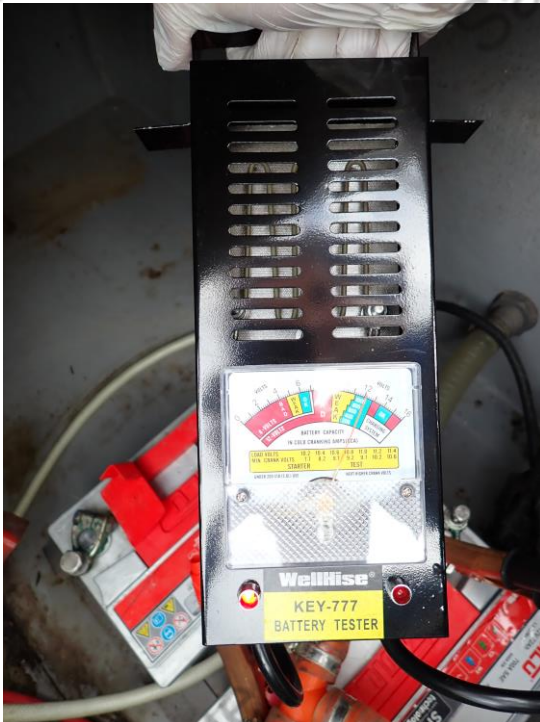
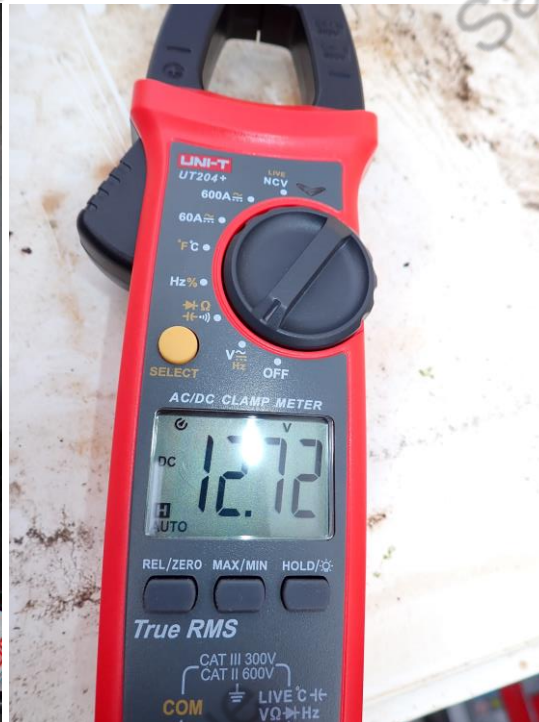
The vessel's DC system is based on a 12 V installation, supported by two Mutlu 12 V 72 Ah batteries, both of which had been intentionally disconnected for winter lay-up at the owner's instruction.

Static voltage checks indicated 12.63 V and 12.72 V respectively, while independent load testing suggested the batteries were slightly below optimum charge condition, although still consistent with recoverable lay-up discharge. Given that both batteries were reportedly replaced during Summer 2025, their present condition is considered acceptable provided they are reconnected and fully recharged without undue delay.

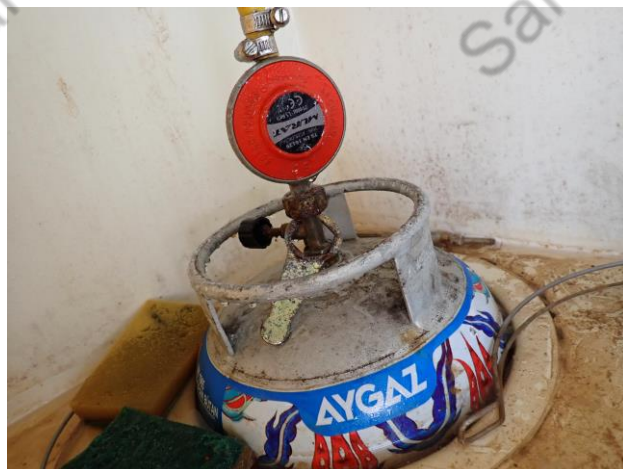
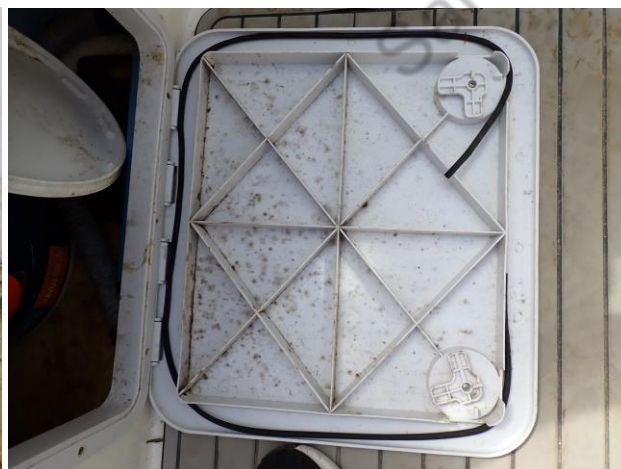
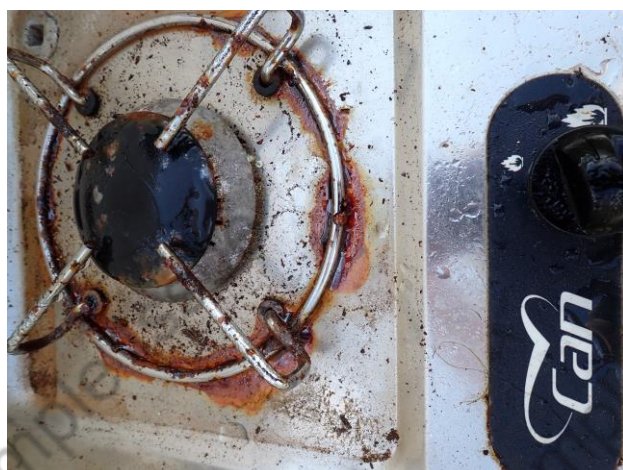
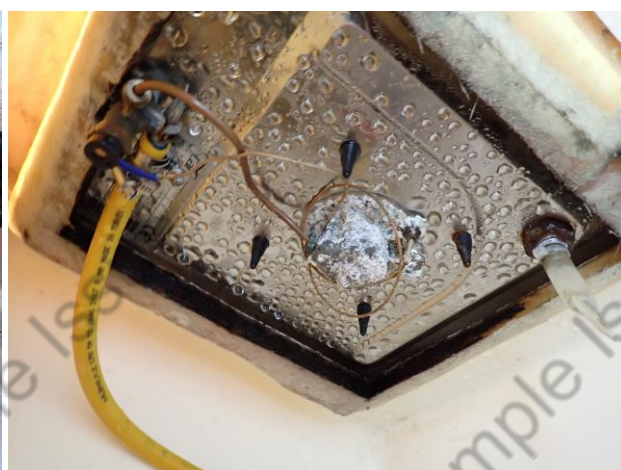
The LPG cylinder itself is retained within a recessed locker chamber and is physically stable in normal static condition, although no dedicated retaining strap or positive securing bracket was fitted, which should be fitted as a basic safety improvement.

Rainwater accumulation was present within the LPG locker, indicating either ineffective drainage or secondary water ingress from the deteriorated exterior cover. The underside of the LPG locker hatch cover exhibited visible mould spotting, dirt accumulation, and moisture staining, particularly along the gasket margin and reinforcement webs. This is consistent with prolonged damp conditions within the locker space and confirms inadequate ventilation and/or repeated rainwater ingress. The hatch cover and sealing gasket should be thoroughly cleaned, disinfected, and inspected for compression loss or discontinuity to ensure the locker remains as dry and vapour-tight as practicable. Particular concern is noted regarding the LPG regulator, which exhibits advanced corrosion and should be replaced immediately before further gas system use.

The stove assembly is heavily corroded and currently below desirable service condition, requiring either professional overhaul or full replacement before the vessel is returned to normal domestic use.

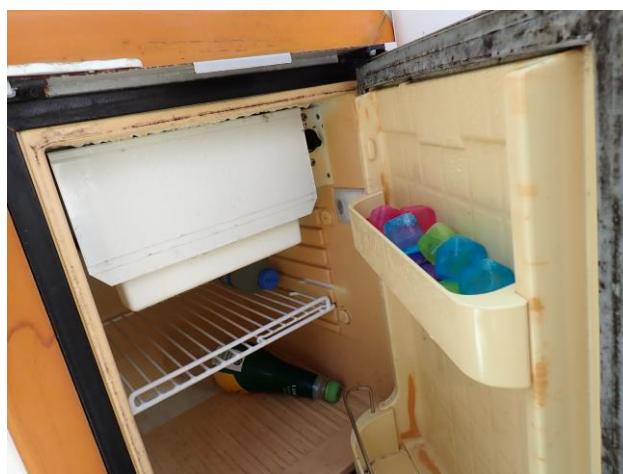
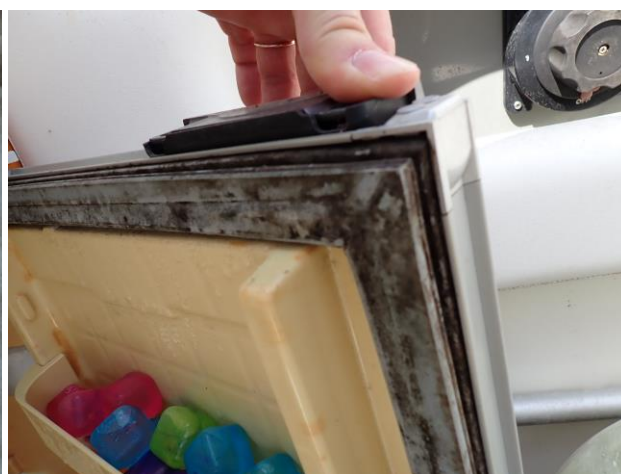
The compact cockpit refrigerator remains fitted and functional in principle, although mould growth was noted around the door sealing surfaces, indicating the need for sanitation cleaning and seal inspection.

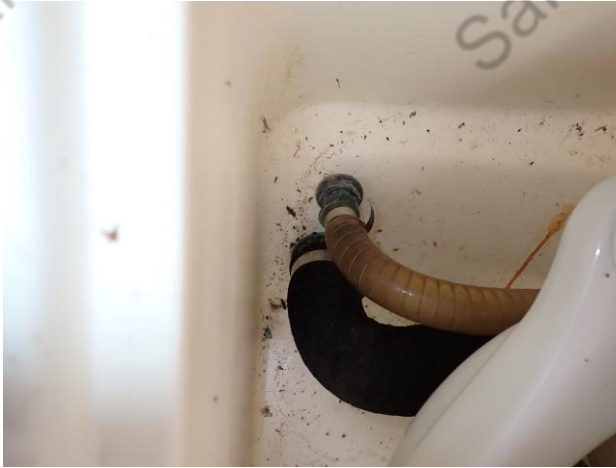
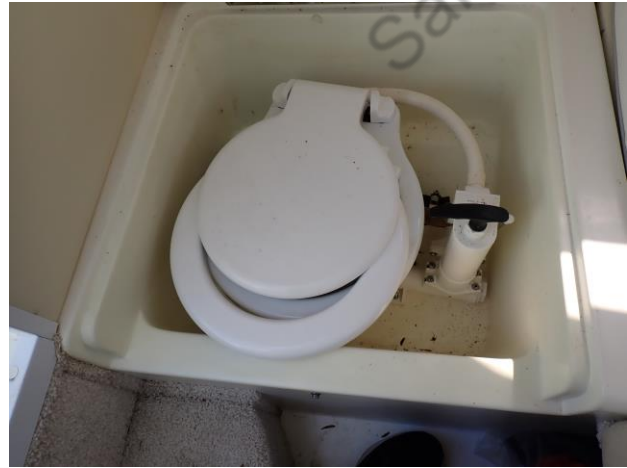
The toilet unit itself remains basically serviceable; however, the seat and lid hinge fittings are broken and require replacement.

The discharge hosework was found visually serviceable, with no abnormal odour, permeation, or leakage detected during the inspection. The system discharges directly overboard, and no holding tank installation is fitted.
