## CONDITION SURVEY REPORT FOR 7M GRP MOTOR CRUISER

Date of Survey: April 2026

Location: İzmir Region (Haul-out yard)

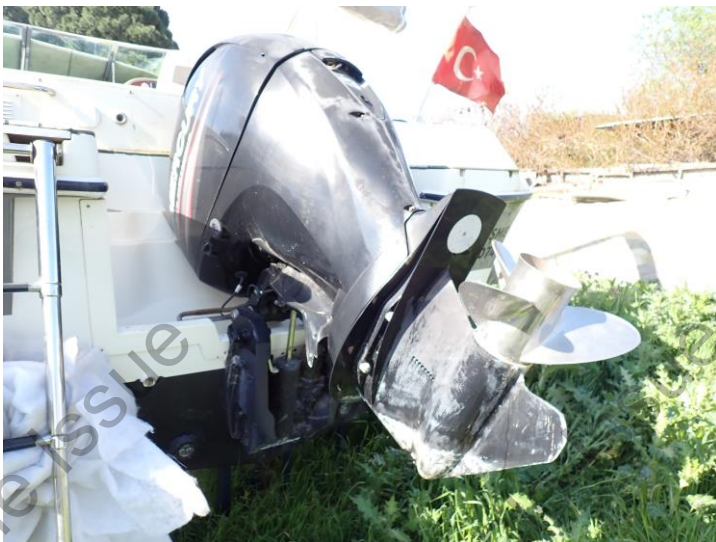
The vessel is fitted with a single Mercury 150 hp outboard engine, reportedly serviced by an authorized service agent during Summer 2025, with the engine hour meter indicating approximately 2465 hours at the time of inspection.

As operational testing was specifically excluded by the owner, inspection was limited to accessible static visual assessment only.

The outboard mounting arrangement, visible fuel-grade hoses, and engine bracket fixings appeared generally serviceable, with no visible signs of mounting distress, active fluid leakage, or hose deterioration in the accessible areas inspected.

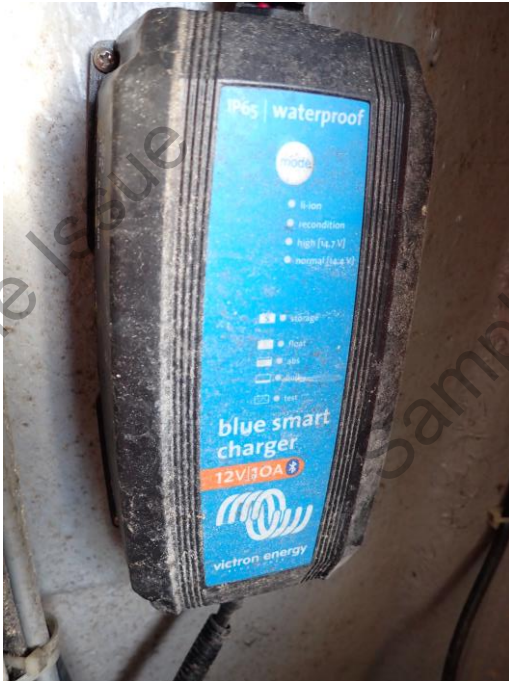
Because the batteries remained disconnected, live operational testing of DC circuits, pumps, lighting, and auxiliary consumers was outside the scope of this inspection.

No inverter or DC-DC conversion equipment is installed.

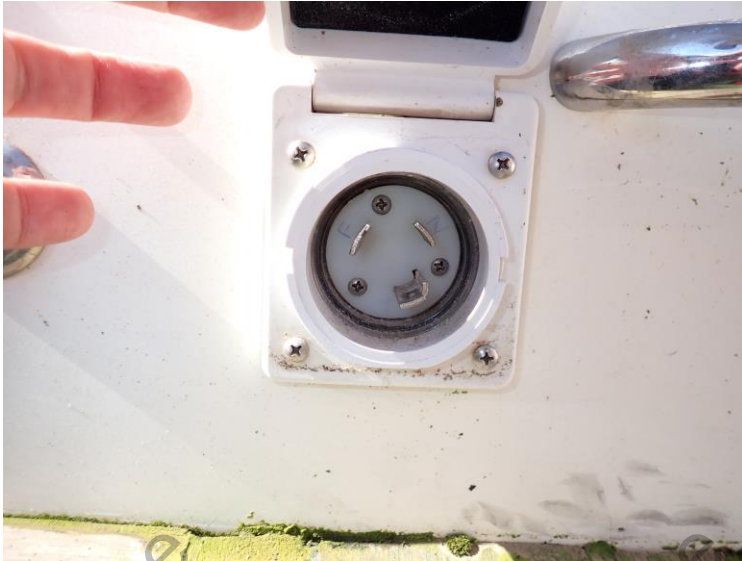
The vessel is fitted with a shore power inlet mounted on the starboard transom, together with at least one internal AC outlet located within the starboard cockpit storage area.

As the system remained de-energized throughout the survey, all AC comments are necessarily limited to installation presence only rather than operational verification.

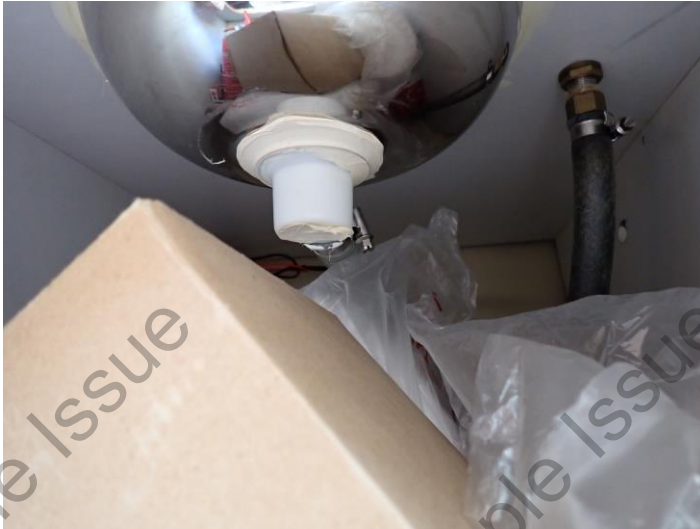
The cabin sink drain remained disconnected at the time of inspection and requires reconnection prior to routine use.

As fitted, the galley is best described as a simple fair-weather recreational installation rather than a full enclosed domestic cooking arrangement.

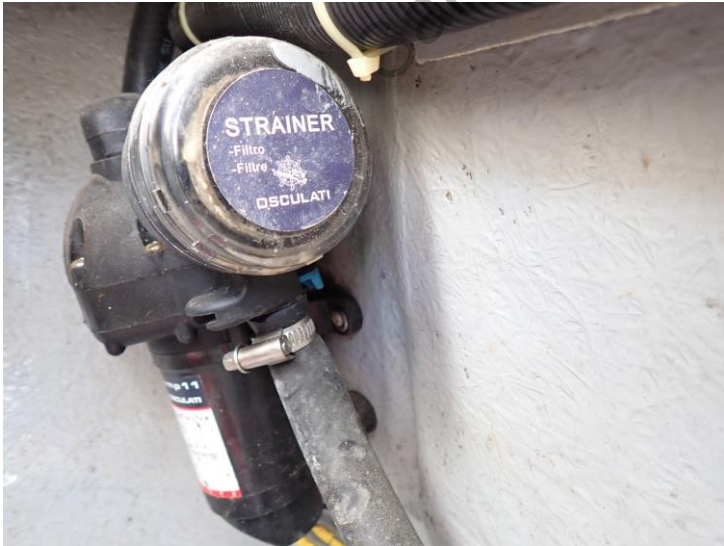
Grey water arrangements are basic. The swim platform shower remains an open discharge arrangement, while the internal basin sink remained disconnected and therefore non-operational at the time of survey.

A single inline freshwater filter is fitted to the Osculati 12 V pressure pump installation, which is considered appropriate for this level of domestic system.
