## IIMS ASSIGNMENT 4 TASK 5A

### SAMPLE CONDITION SURVEY REPORT FOR 7M GRP MOTOR CRUISER

Date of Survey: April 2026

Location: İzmir Region (Haul-out yard)

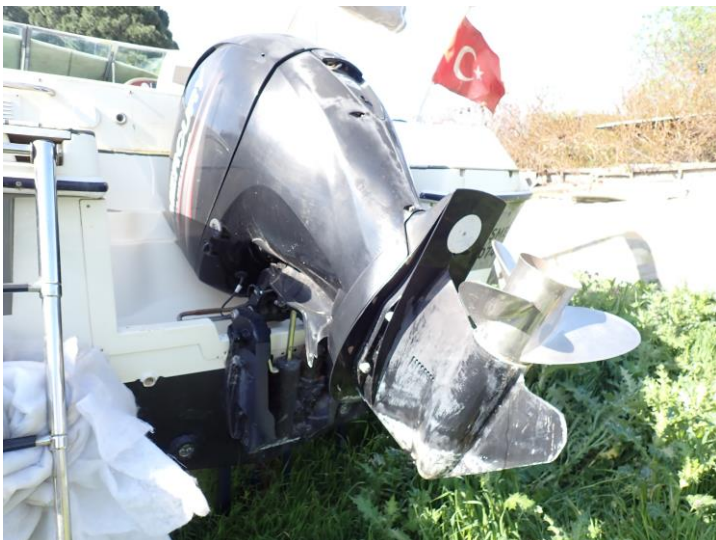
The vessel is fitted with a single Mercury 150 hp outboard engine, reportedly serviced by an authorized service agent during Summer 2025, with the engine hour meter indicating approximately 2465 hours at the time of inspection.

As operational testing was specifically excluded by the owner, inspection was limited to accessible static visual assessment only.

The outboard mounting arrangement, visible fuel-grade hoses, and engine bracket fixings appeared generally serviceable, with no visible signs of mounting distress, active fluid leakage, or hose deterioration in the accessible areas inspected.

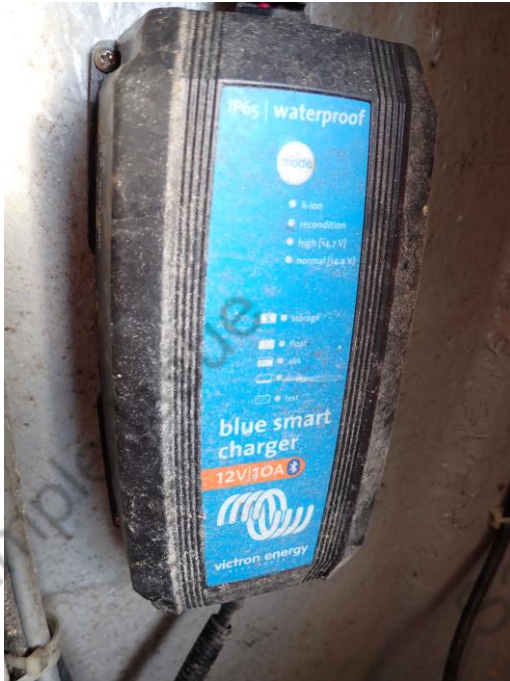
Because the batteries remained disconnected, live operational testing of DC circuits, pumps, lighting, and auxiliary consumers was outside the scope of this inspection.

No inverter or DC-DC conversion equipment is installed.

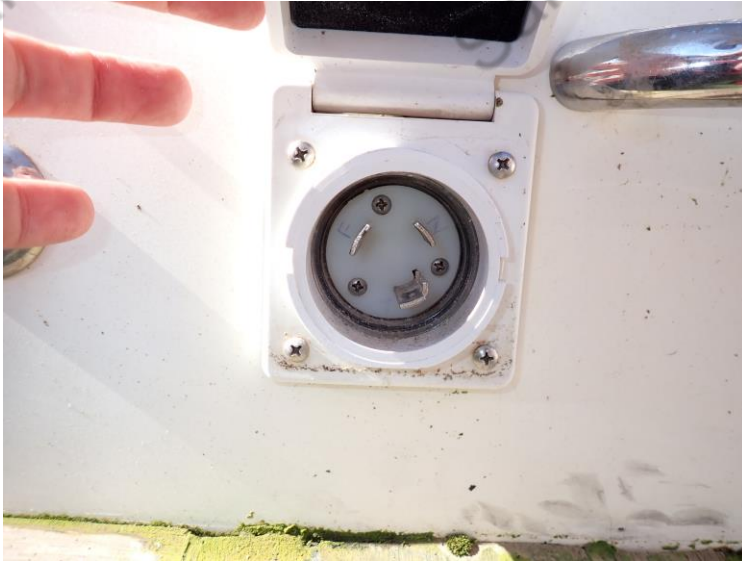
The vessel is fitted with a shore power inlet mounted on the starboard transom, together with at least one internal AC outlet located within the starboard cockpit storage area.

As the system remained de-energized throughout the survey, all AC comments are necessarily limited to installation presence only rather than operational verification.

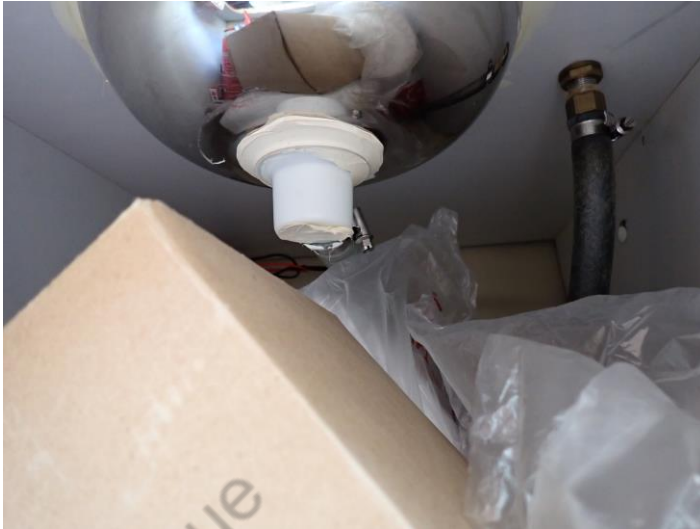
The cabin sink drain remained disconnected at the time of inspection and requires reconnection prior to routine use.

As fitted, the galley is best described as a simple fair-weather recreational installation rather than a full enclosed domestic cooking arrangement.

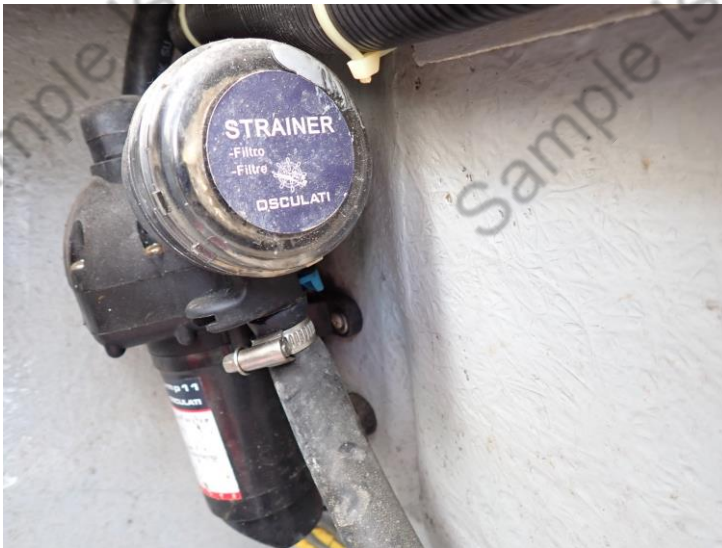
Grey water arrangements are basic. The swim platform shower remains an open discharge arrangement, while the internal basin sink remained disconnected and therefore non-operational at the time of survey.

A single inline freshwater filter is fitted to the Osculati 12 V pressure pump installation, which is considered appropriate for this level of domestic system.

No hot water generation or desalination equipment is installed.
